PROPERTY INSPECTION REPORT

**Matthew Batson License #
True Value Home Inspections LLC**

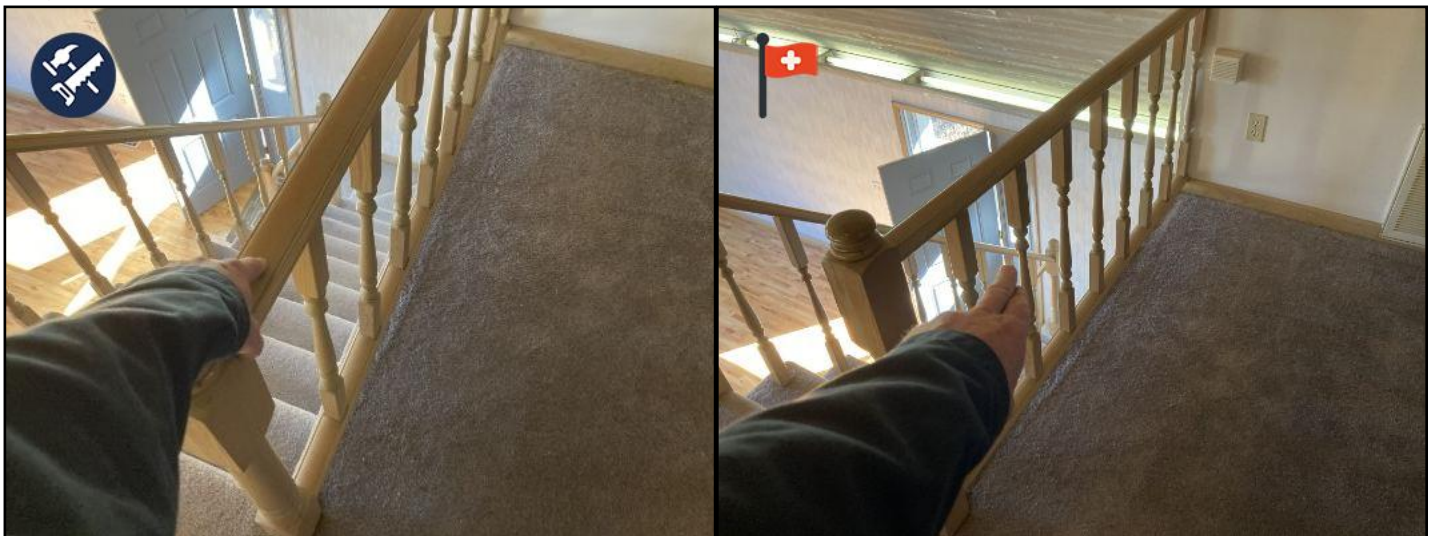
the handrail at the second floor loft is a bit loose. Recommend this be shored up/reinforced in case someone were to accidentally fall against it.

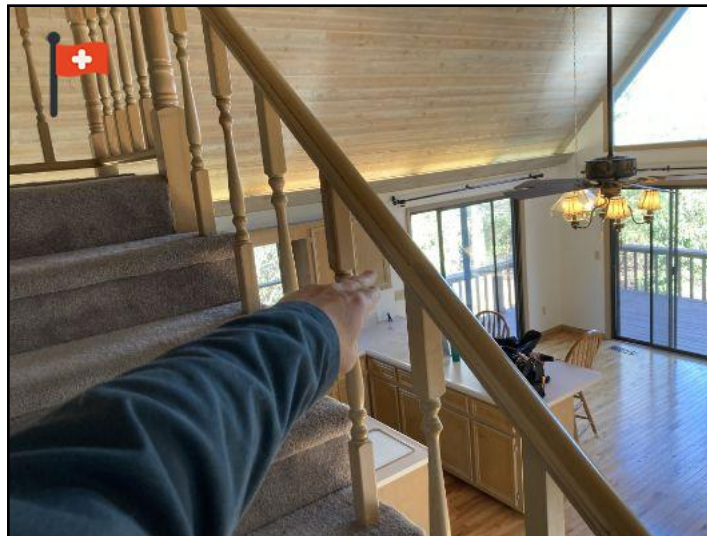
the handrail for the steps up to the upstairs loft are a bit loose. They feel as if they could be reinforced a bit to ensure safety if an accidental fall.

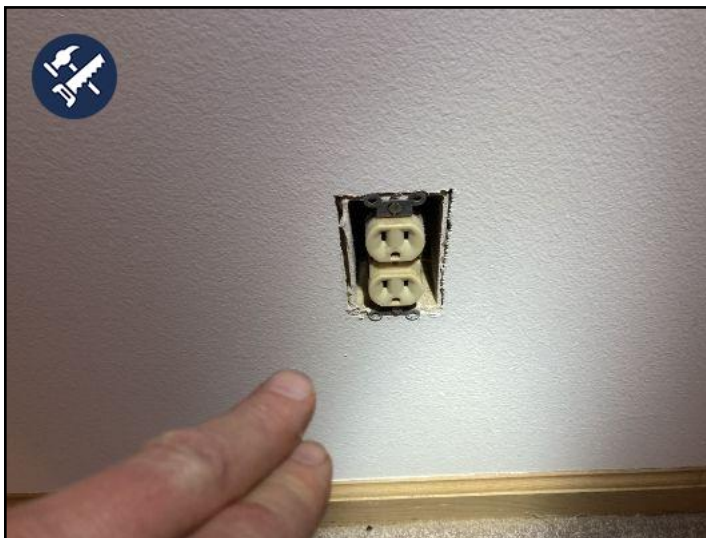
outlet needs a cover.

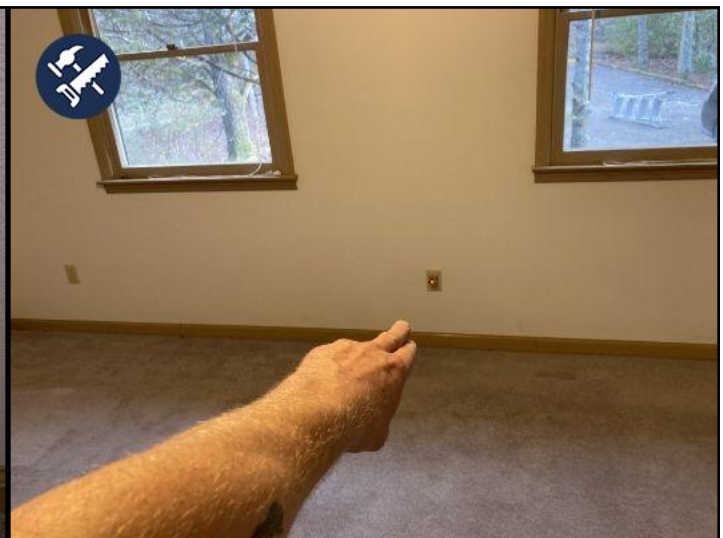
this outlet in the first floor bedroom is not grounded. This is the only one in the house...indicating to me that the receptacle itself was miswired or is defective. Recommend replacement

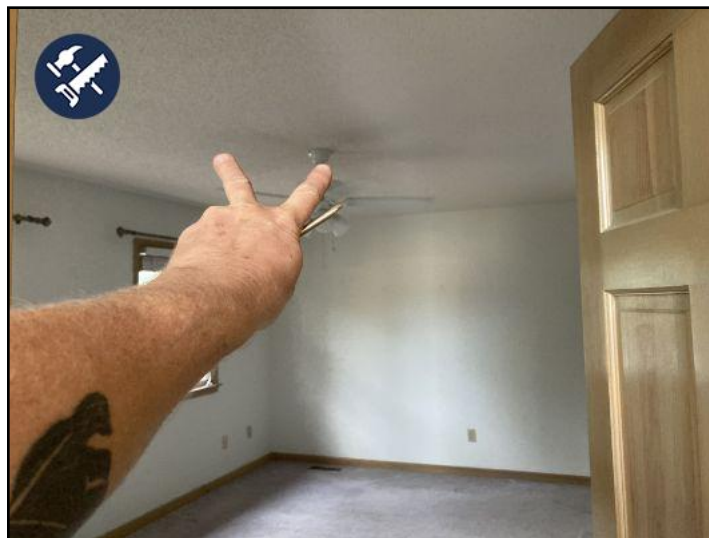
no smoke detectors in the bedroom downstairs. Recommend combination carbon monoxide/smoke detectors due to the wood burning fireplace in the home

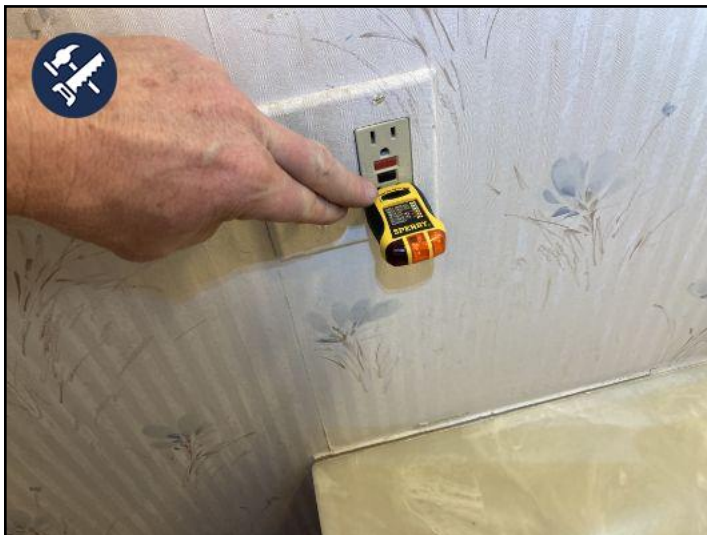
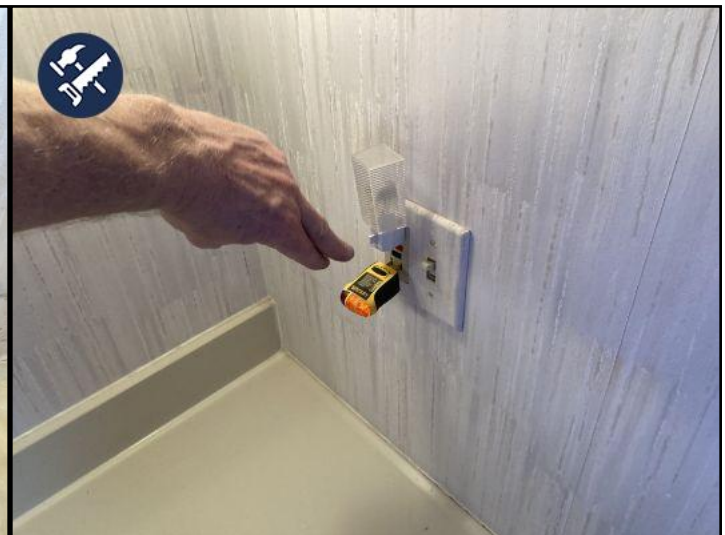
neither bathroom GFCI tripped on my tester. These wear out over the years. Recommend replacement.

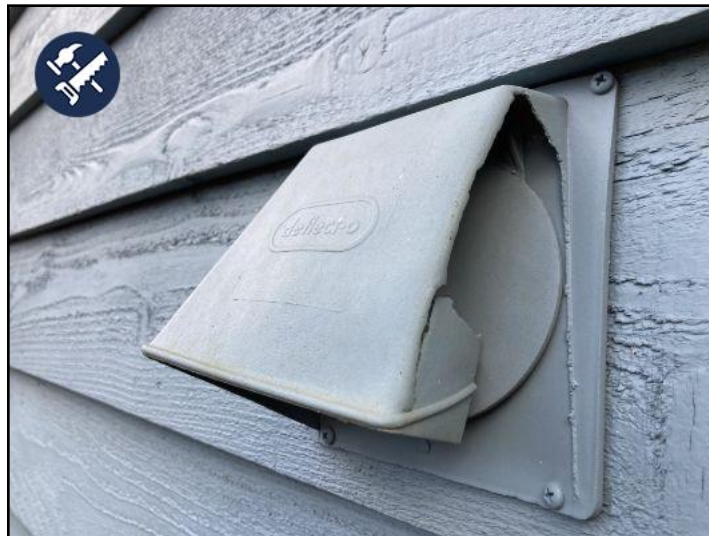
the upstairs bathroom vent is damaged. Recommend replacement.

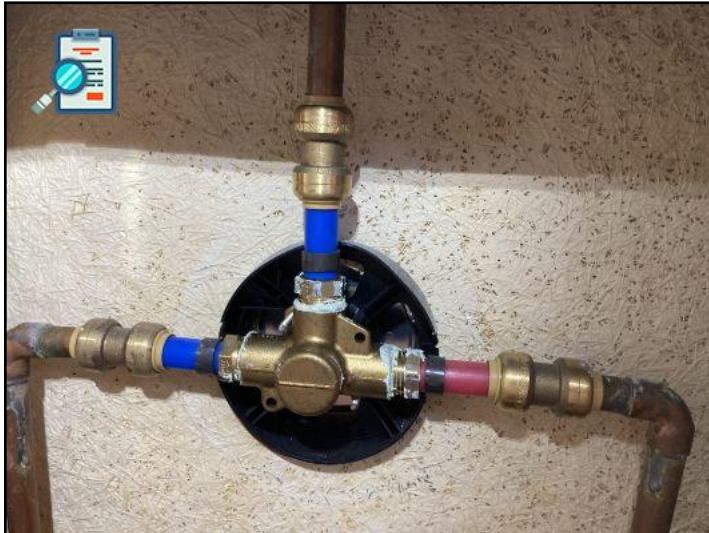
while the visible copper plumbing was in good shape...it will eventually fail. Unknown how long that could be....could be another 30 years.

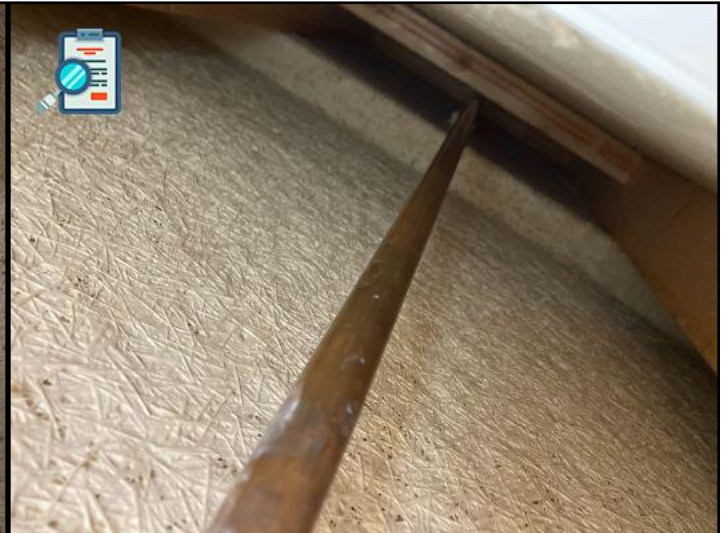
copper plumbing throughout the home. Copper has a life span and will eventually wear out/corrode and leak. Recommend budgeting for complete removal of all copper and replacement with pex.

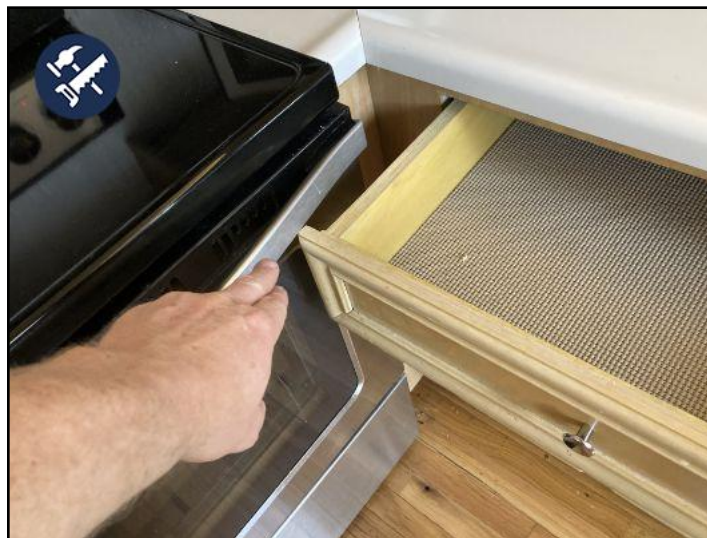
this drawer comes into contact with the stove before it is fully open.

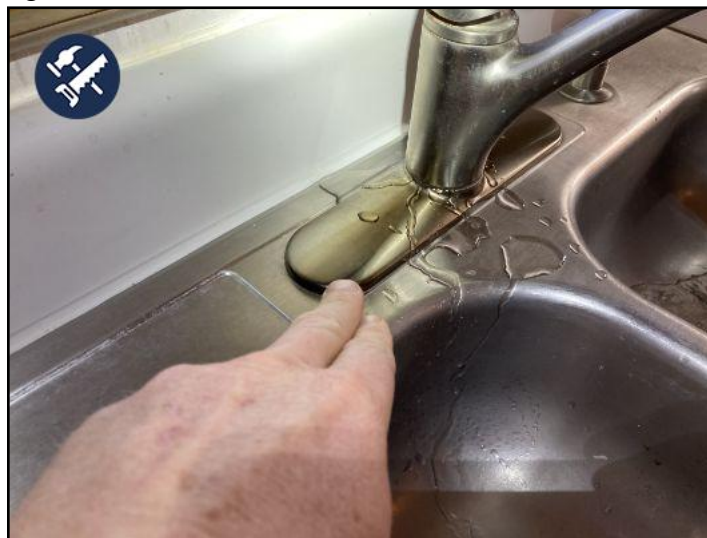
kitchen sink faucet leaks. Recommend replacment by plumbing contractor

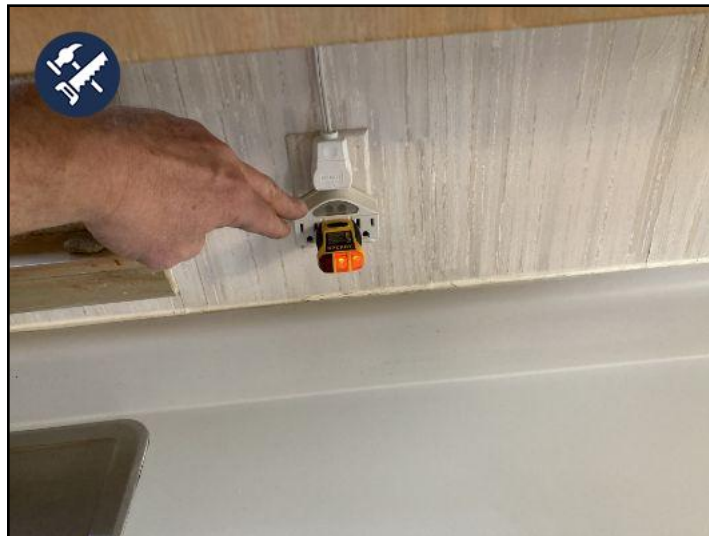
outlet next to kitchen sink is not a GFCI. This can be a shock hazard. Recommend replacement by electrical contractor

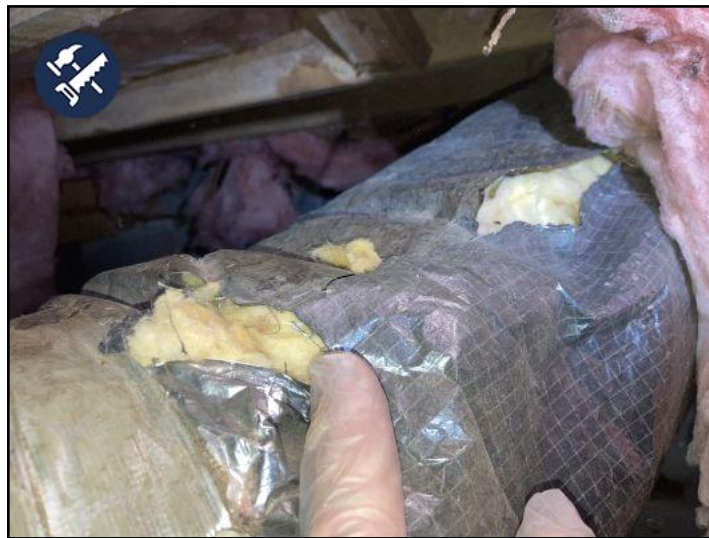
- several places of damage/tears to the HVAC supply duct in the crawlspace.

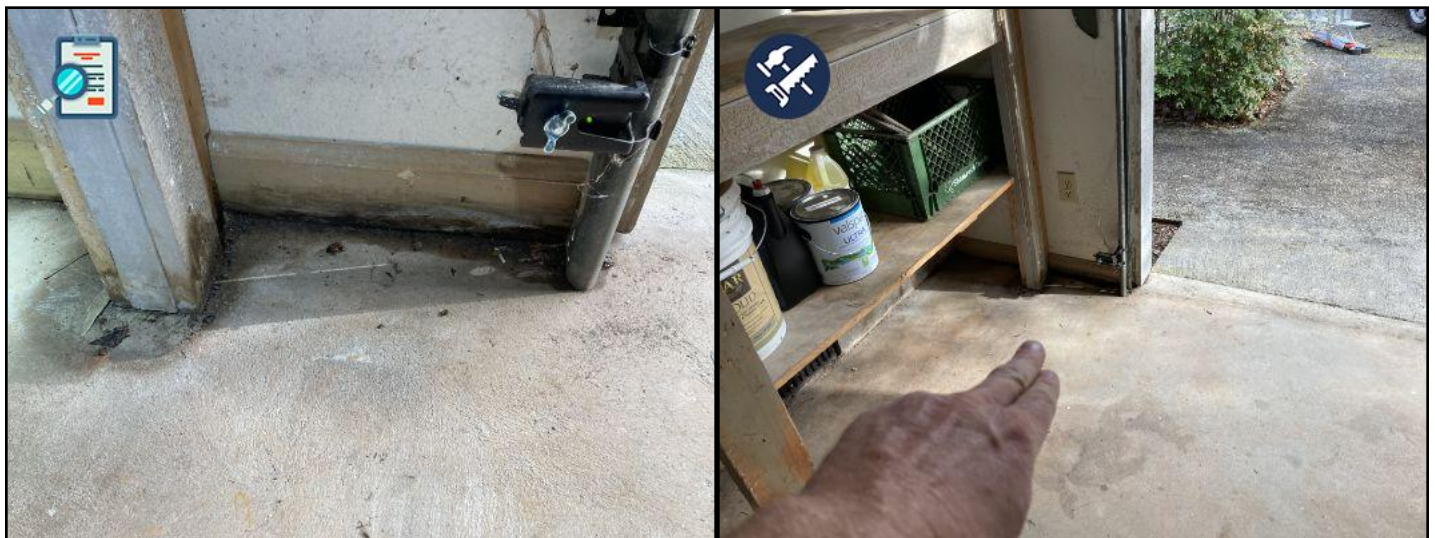
some water staining next to garage door...is not wet currently and wood is still structurally fine...monitor for possible water issues

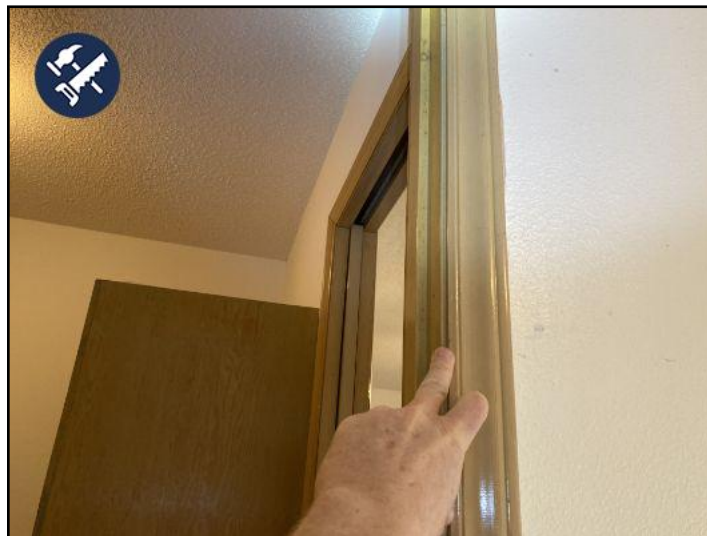
the door to the house from the garage has no weatherstip. This is important due to fumes in the garage that could possibly penetrate to the home interior. Recommend installation of weatherstrip here.

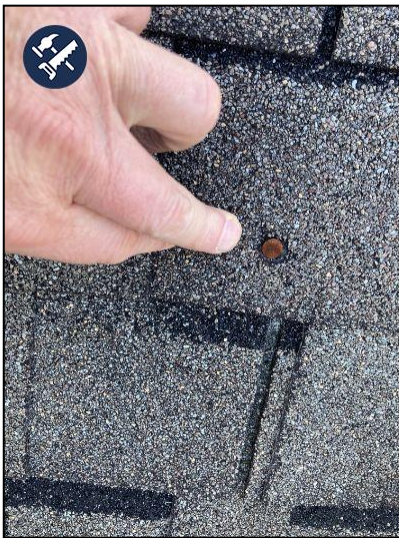
a nail in the exposure part of the shingle is not proper buidling practice. Recommend a dab of roofing cement over this nail head.

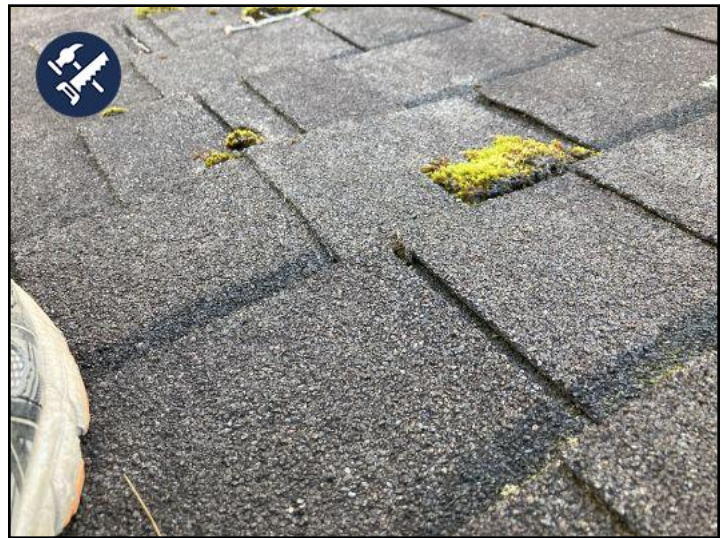
moss on the roof will shorten an asphalt shingles lifepan. Recommend spraying a fungicide on the affected areas every couple of years.

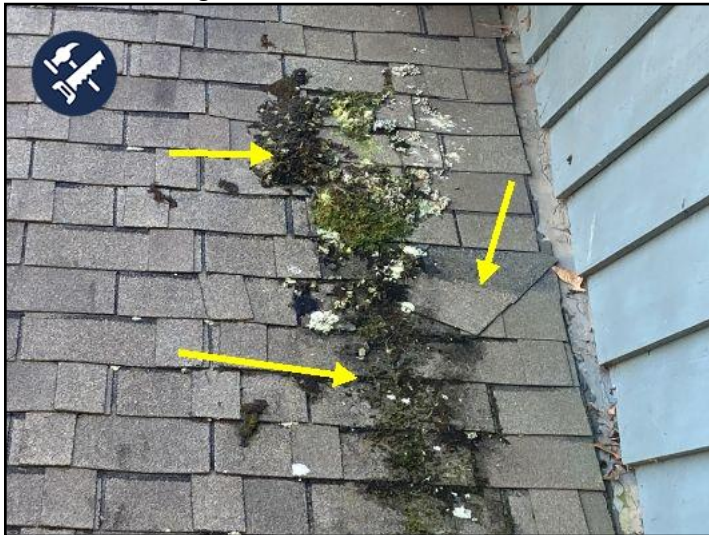
a shingle tab has slid down out of place. It does not appear to be leaking at this time...however it should be repaired by a roofing contractor. Also the moss growing here needs to be sprayed with fungicide.

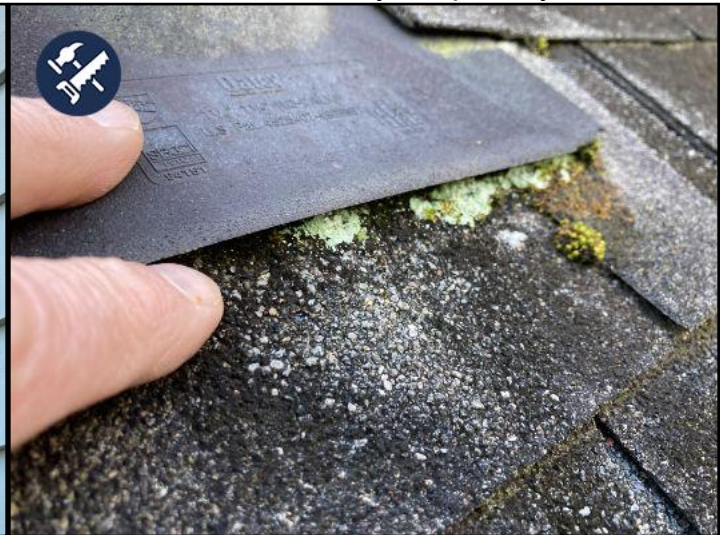
most of the mold is on the north facing parts of the roof

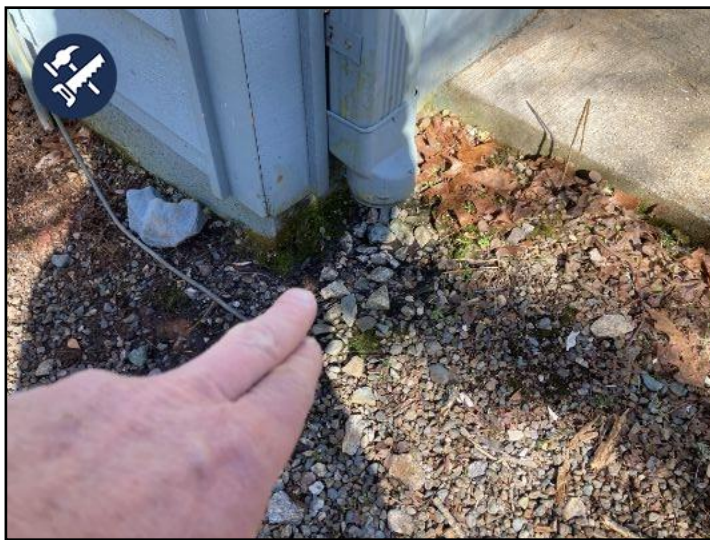
gutter downspout needs an extension to ensure water is discharged further away from the foundation. This will cause issues with the foundation over time...washing soil away and introducing excessive moisture next to the home.

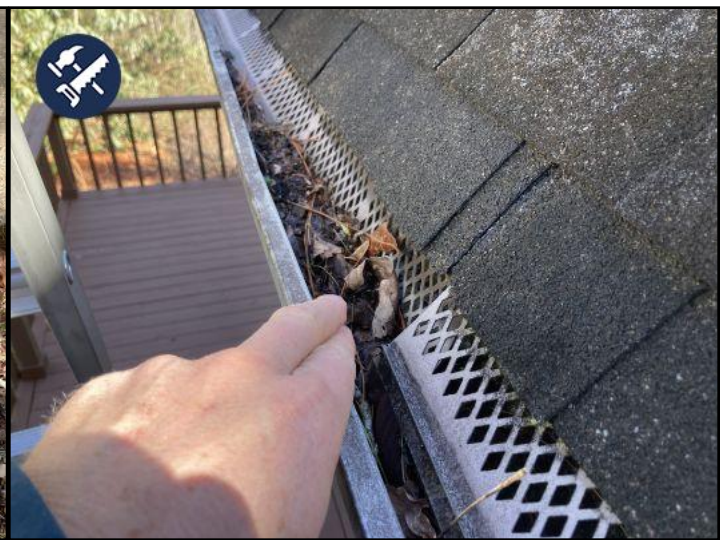
a couple spots of the gutter guard are in disrepair and leaves are accumulating. Recommend cleaning gutters and popping this back into place in the gutter.

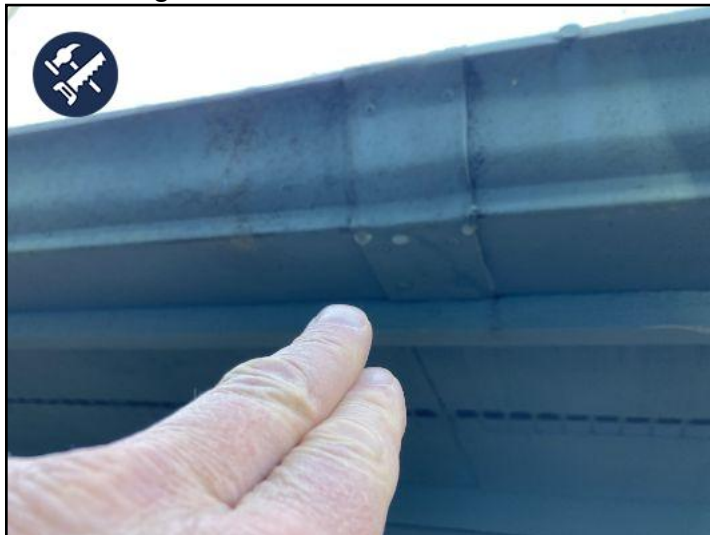
leaking gutter at the detached covered porch in the back. This is introducing moisture next to the deck. Recommend sealing with some gutter glue.

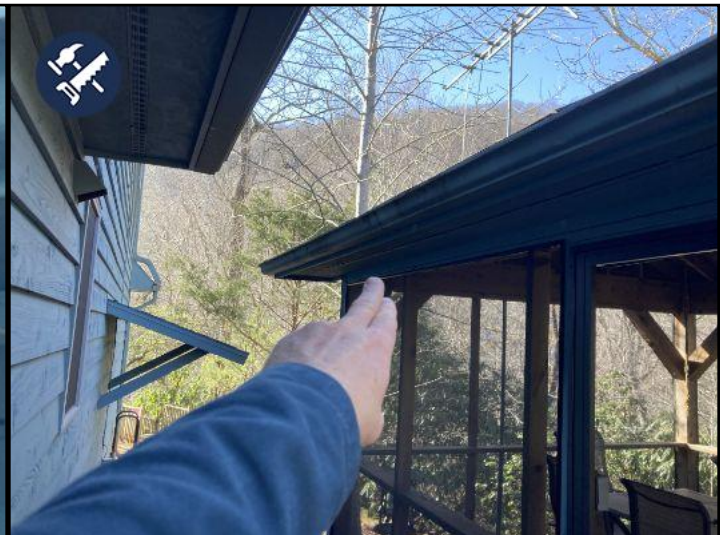
location of leaking gutter.

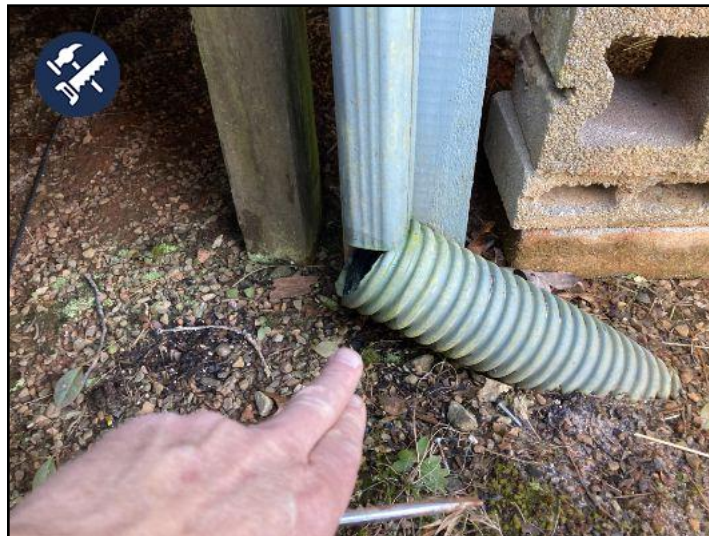
downspout is not connected to the drain pipe. Recommend correction to ensure water is discharged away from the home.

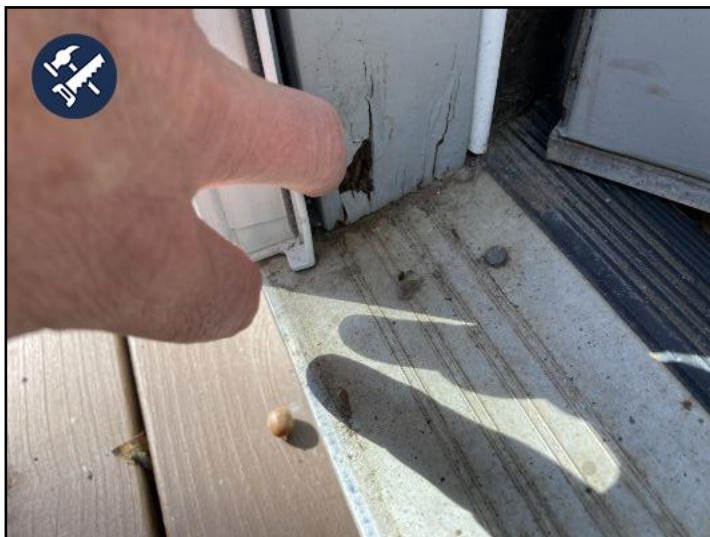
front entry door has some rotting wood on its frame. Recommend repair by qualified contractor

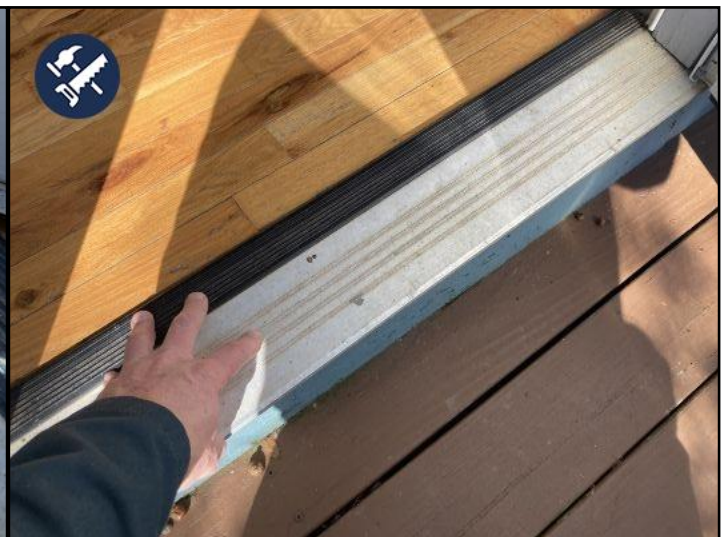
front door threshold is loose and in disrepair. Recommend repair or replacement by qualified contractor

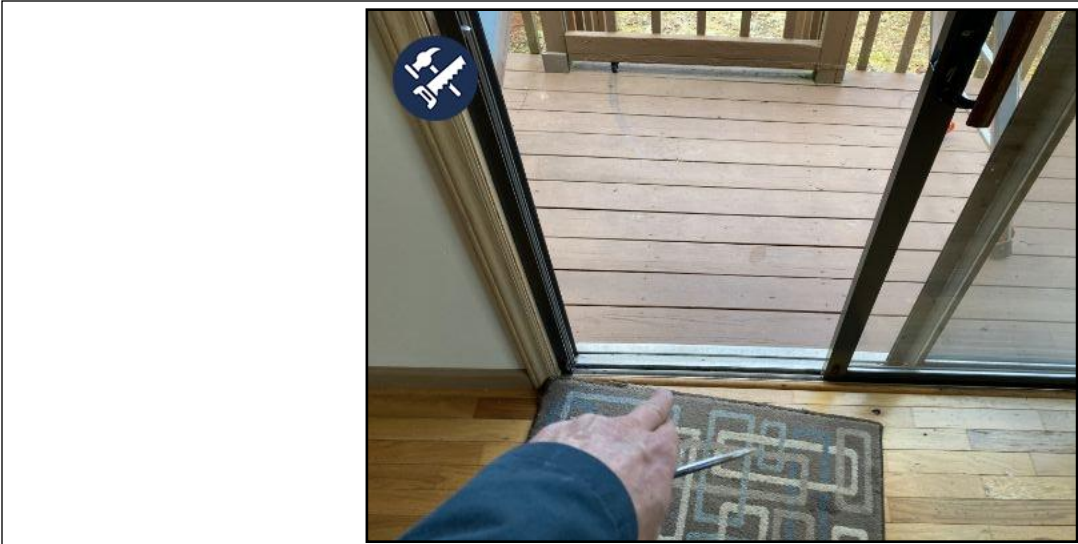
Page 42 Item: 2 | Window Condition • **Some window screens damaged.**

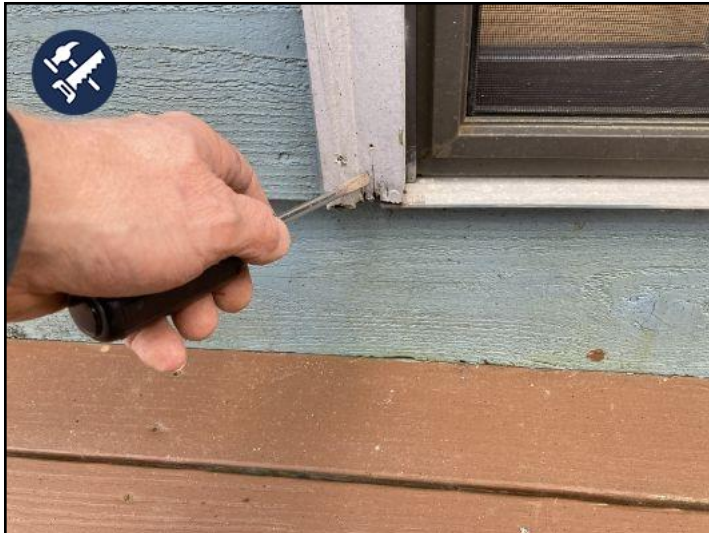
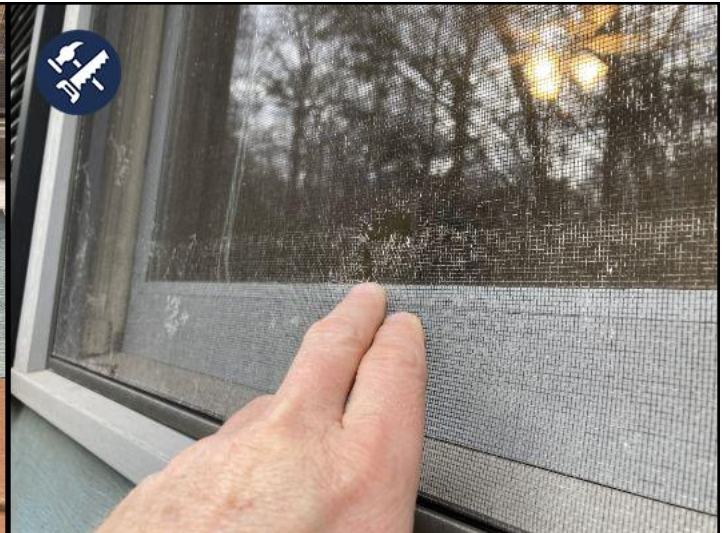
This trim at sliding glass door is beginning to rot. Door facing back yard. Recommend repair by qualified contractor

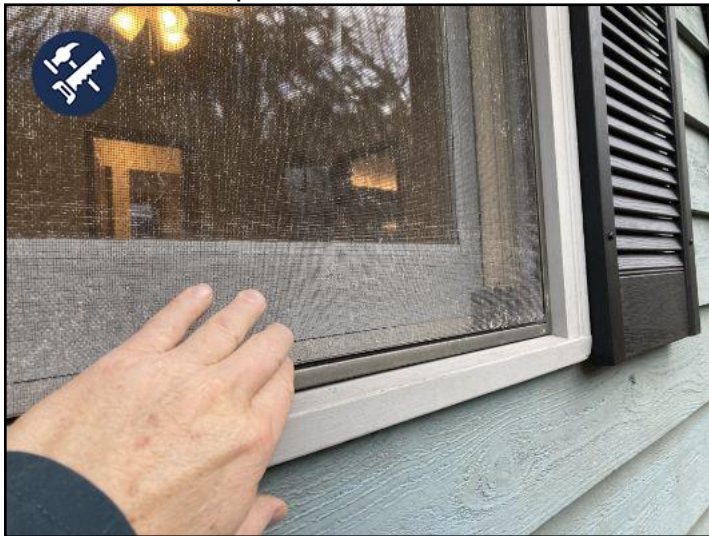
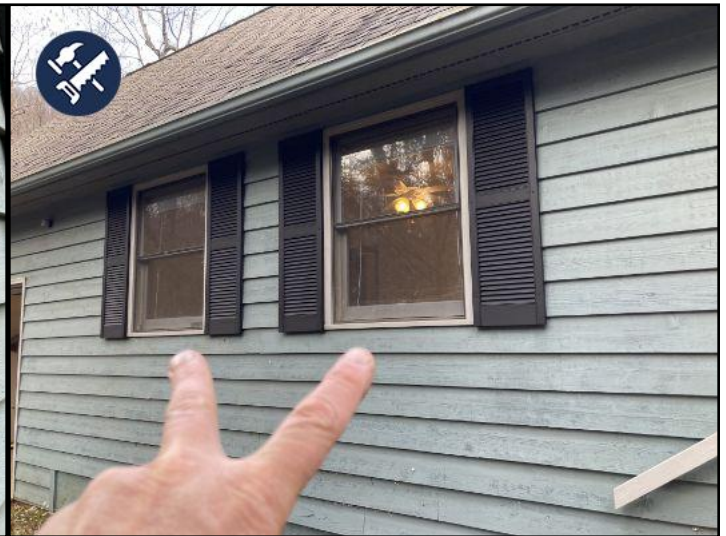
Page 44 Item: 2 Grading

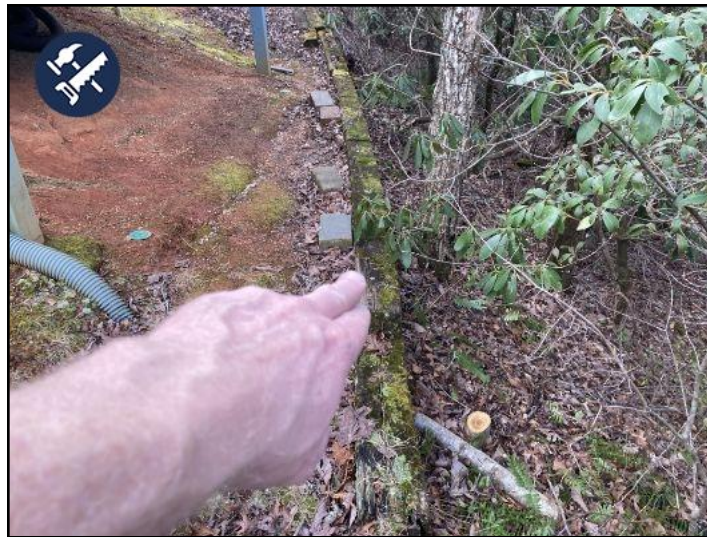
the retaining wall at the back of the home is in disrepair. The railroad timber used is rotted and failing. This wall will need to be replaced in the near future.

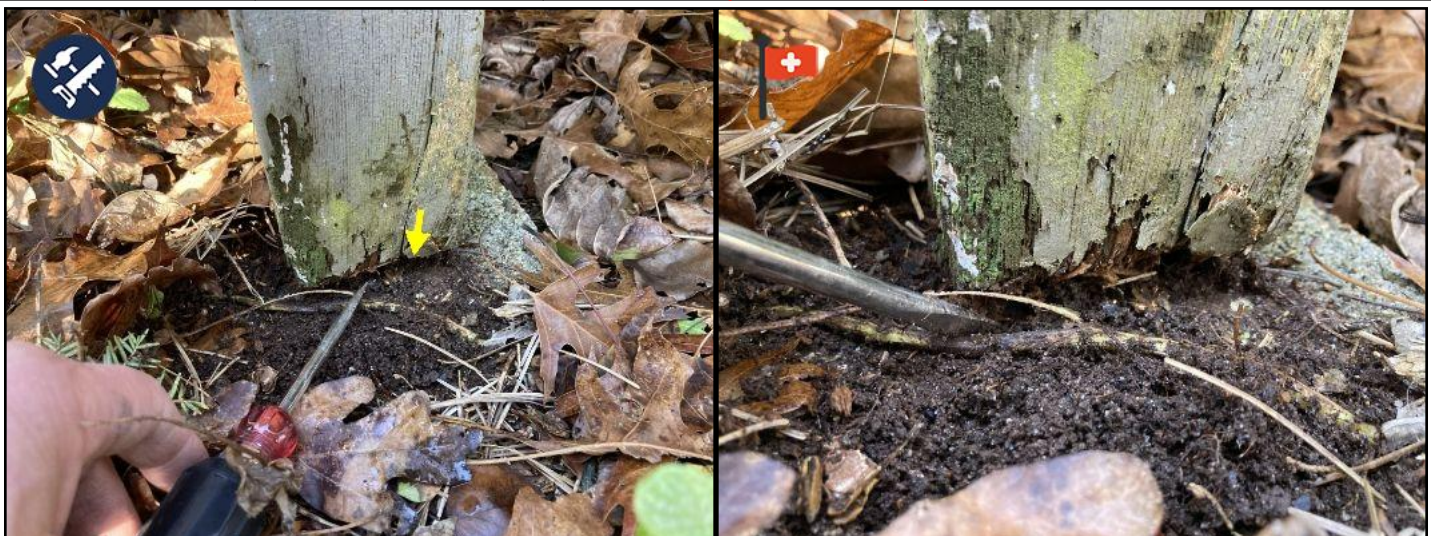
several fo the 4x4 support posts on the deck (at the front , sides and back) are rotting at the point where they meet their concrete footers.

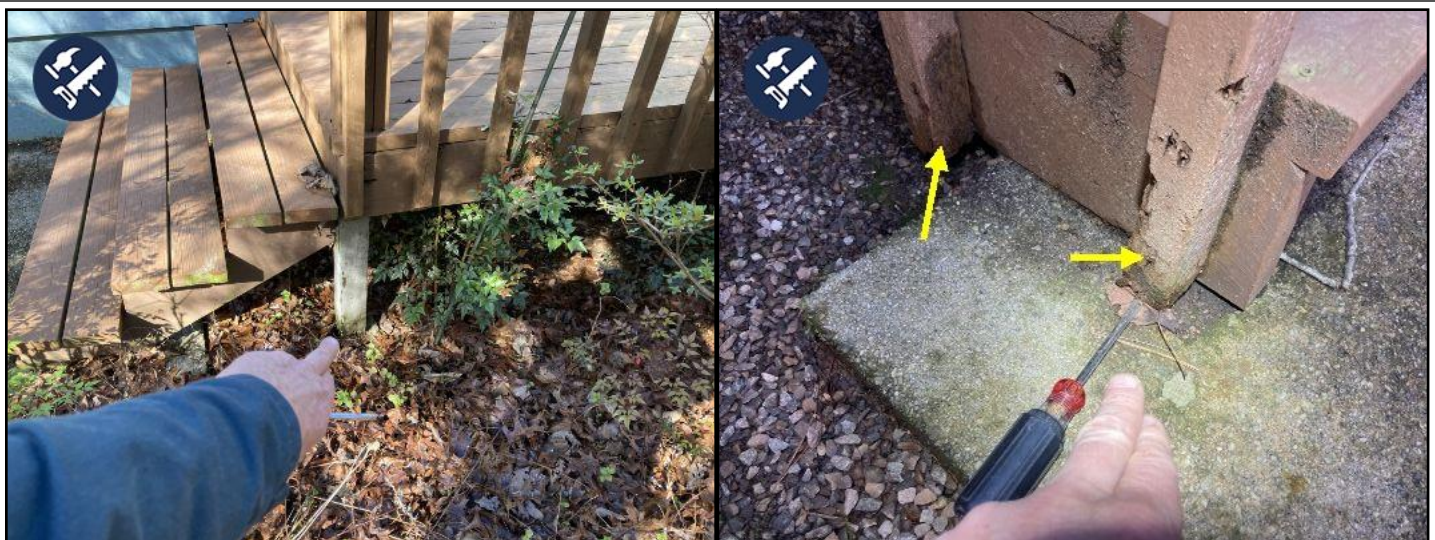
at the steps to the rear deck nearby the a/c compressors....there is rotted wood at the balusters. This handrail is also loose and in need of reinforcement.

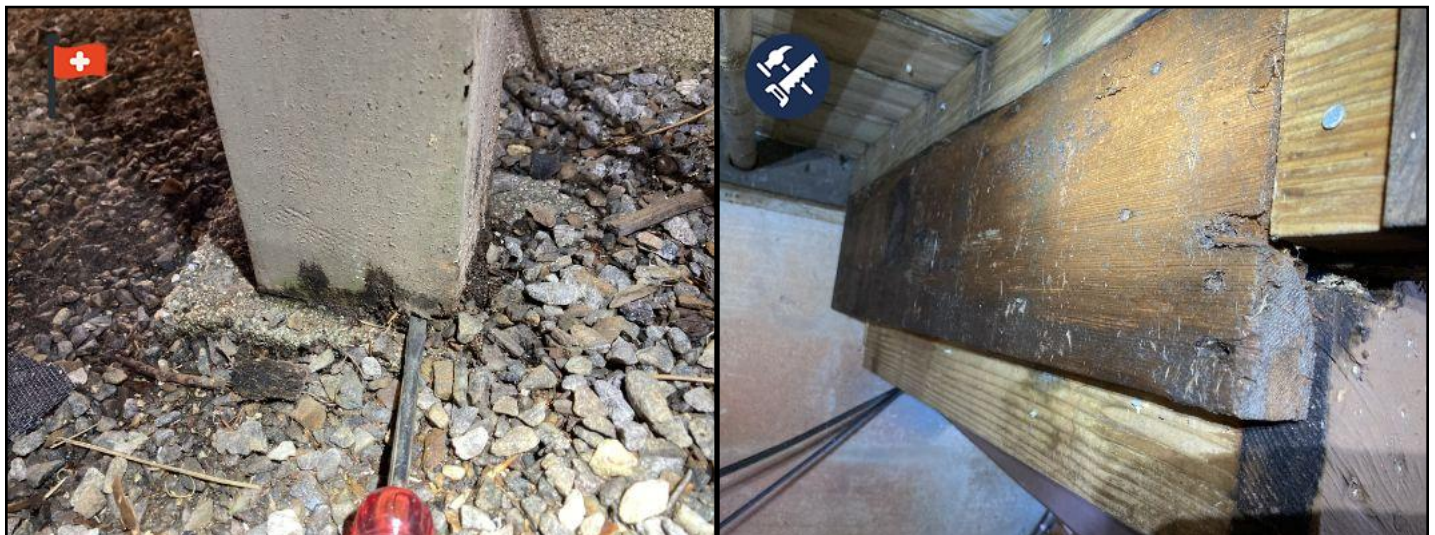
another 4x4 post that is beginning to rot from water exposure/contact with concrete footer.

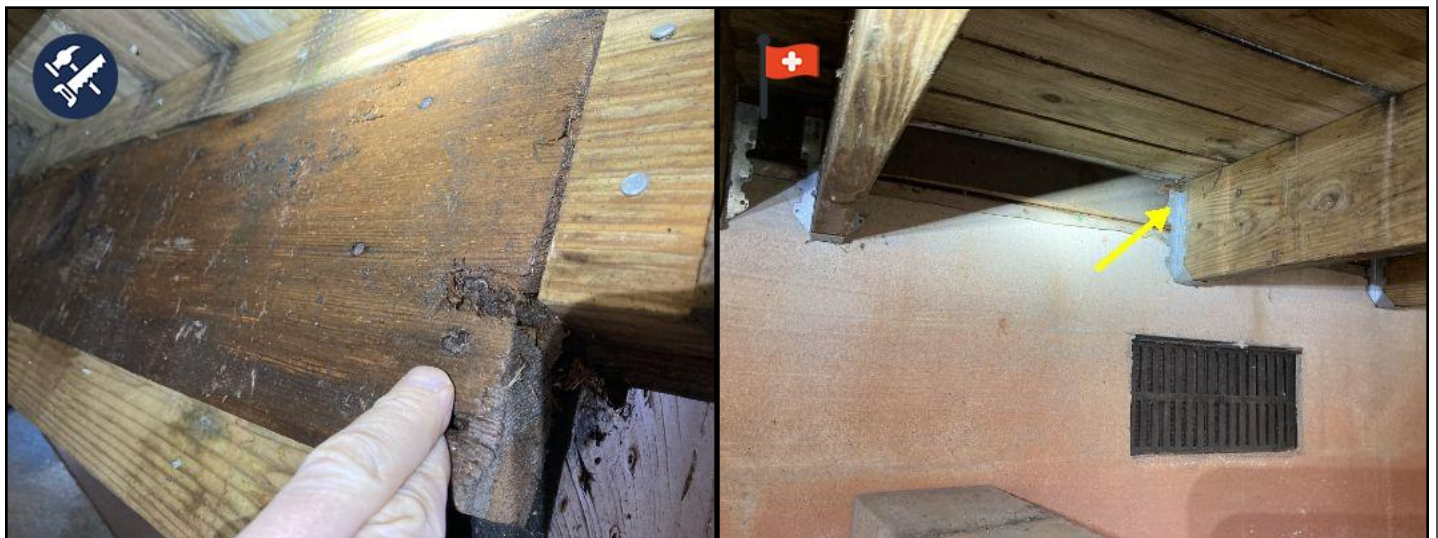
the deck is not properly attached to the home. Most deck failures occur at the attachment point at the house. The hangers for the joists are not fully bearing on the ledger. The ledger is not bolted or structurally screwed to the home. Recommend evaluation and repair by qualified contractor

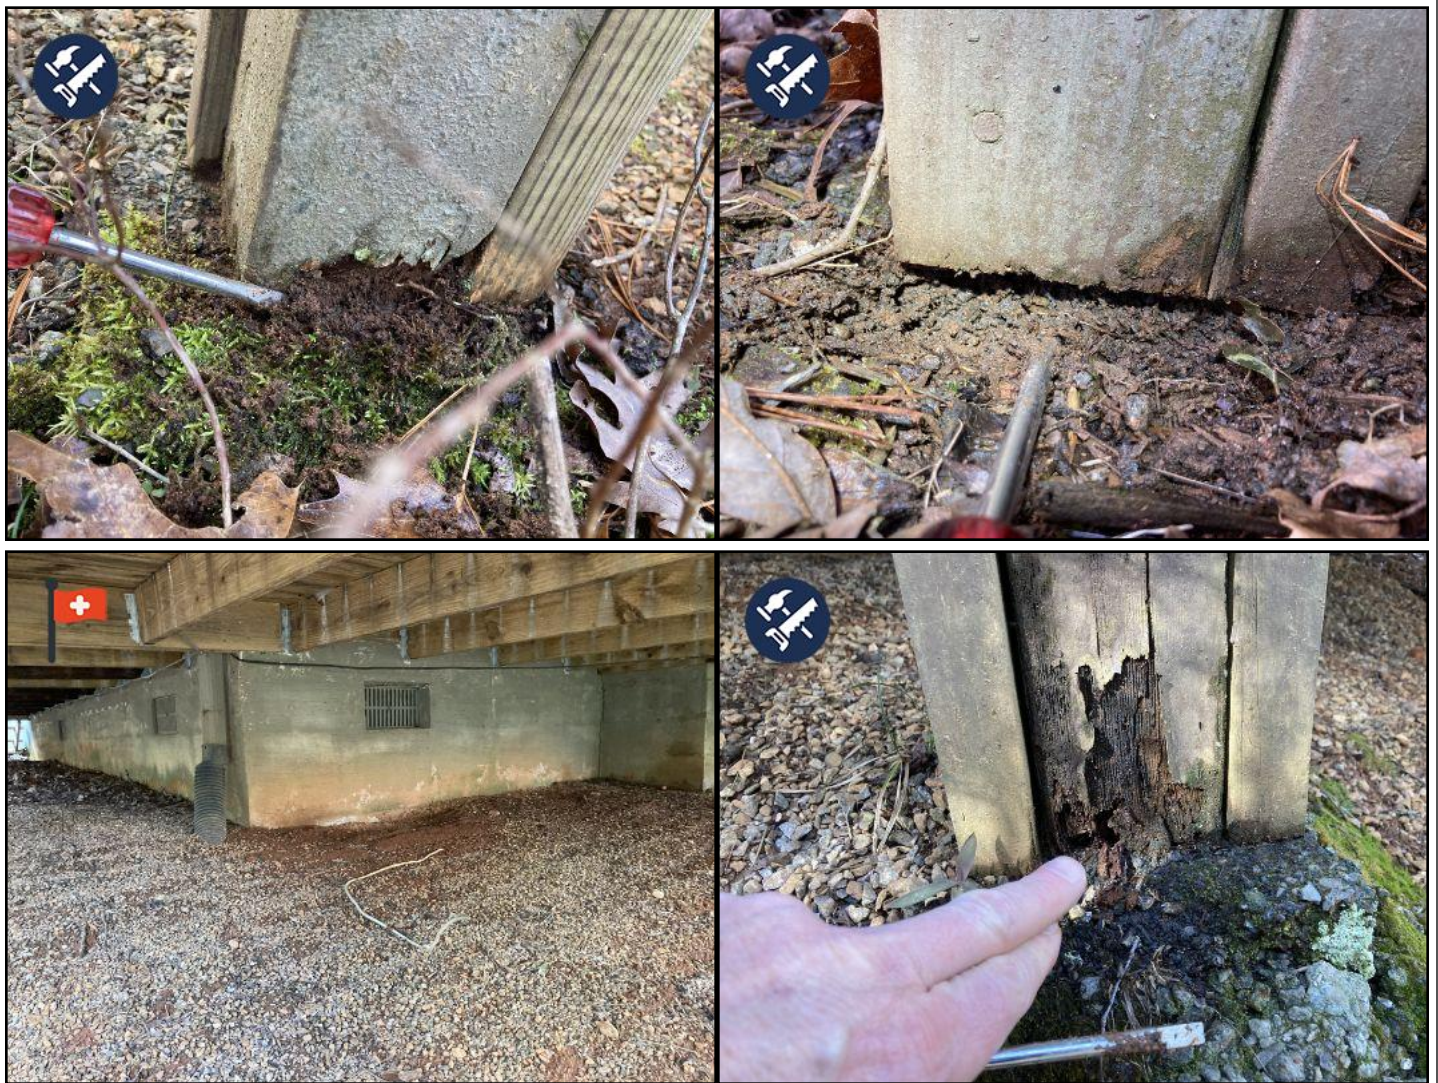
the deck at the house is a safety hazard. With enough people on it this deck could collapse with its improper attachment to the home. 85% of deck failures occur at the attachment to the home. This deck needs to be repaired immediately

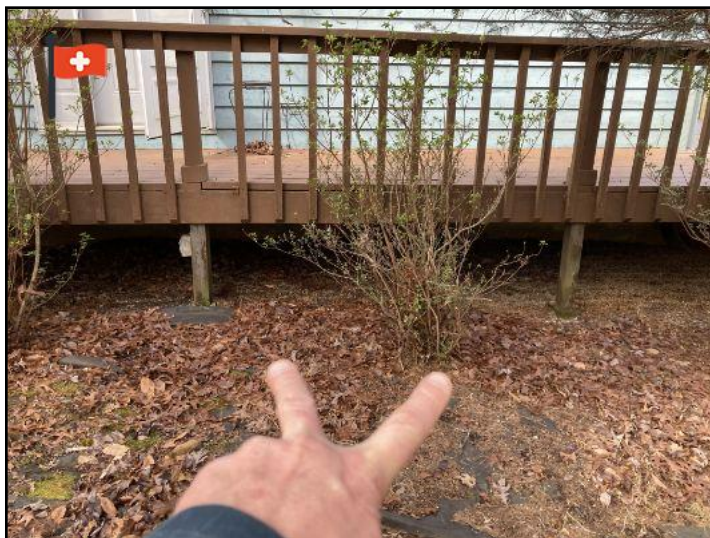
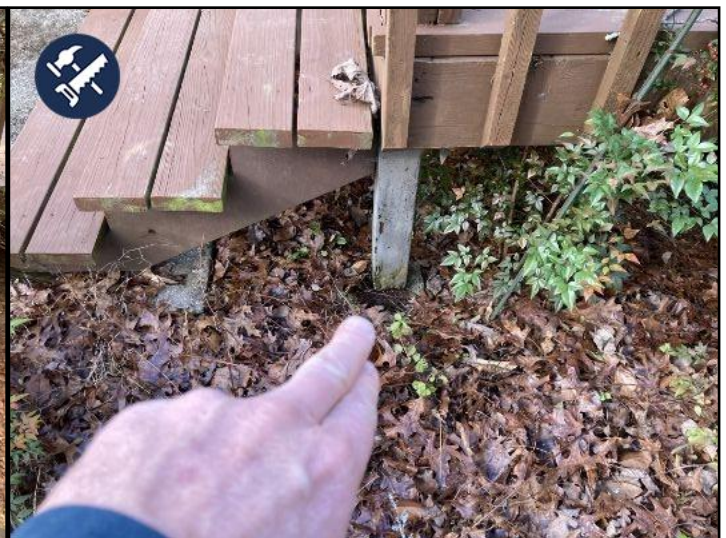
these two 4x4 posts are rotting...among others on the deck. This is a safety hazard as the deck is not properly supported and is not performing as designed.

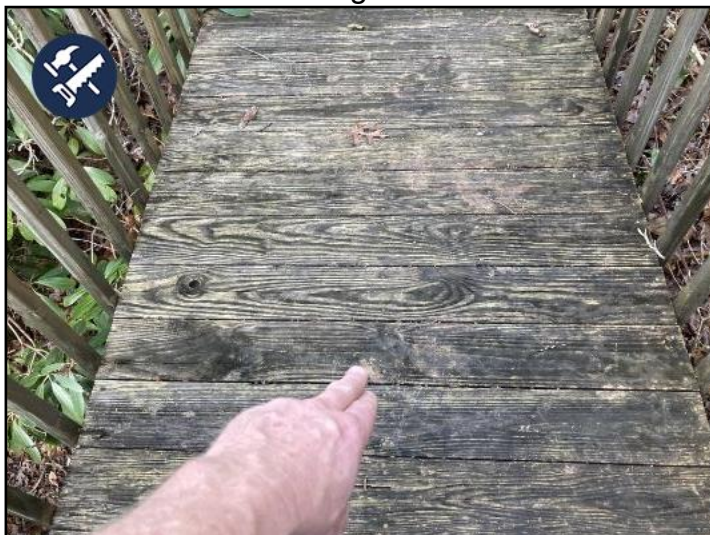
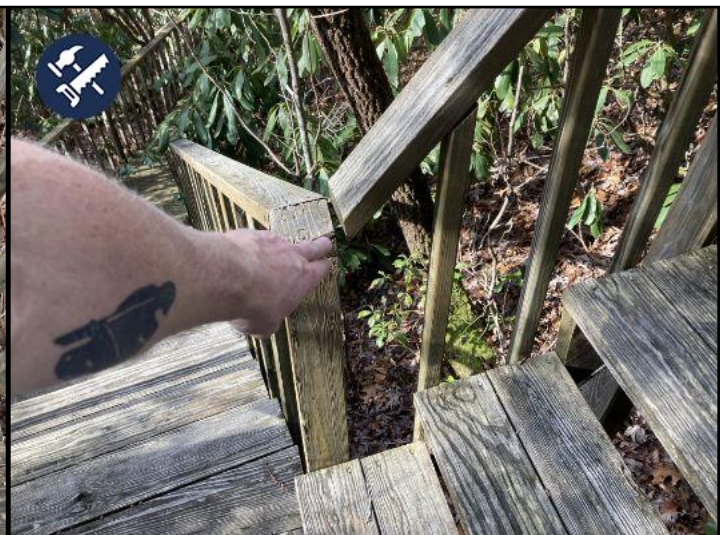
there are several areas of the deck down to the creek that are in need of treatment/washing and staining/paint. The wood decking is heavily weathered.

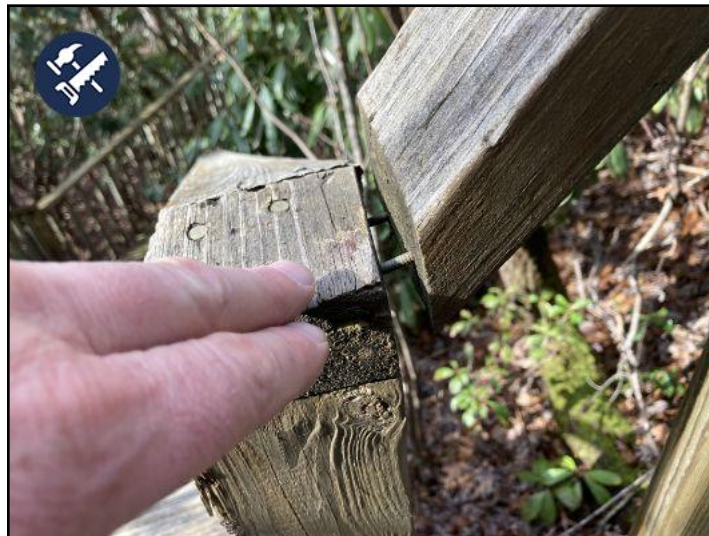
handrail is coming loose from its mount here...recommend repair

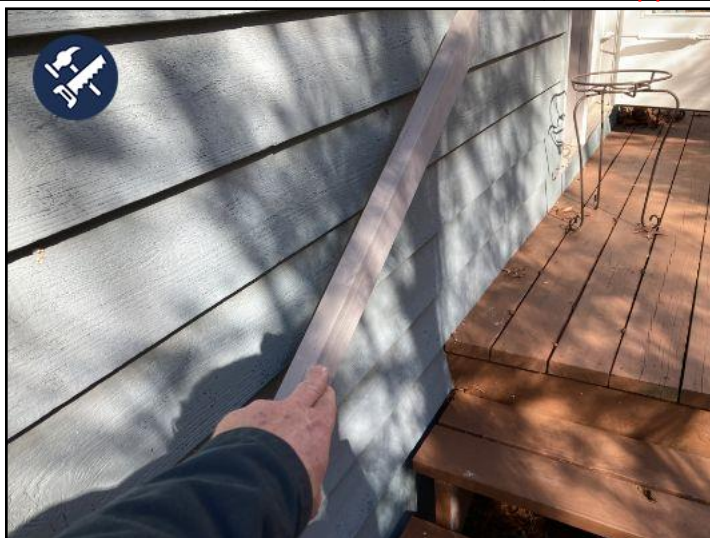
handrail at front entry steps is loose.
Recommend repair.

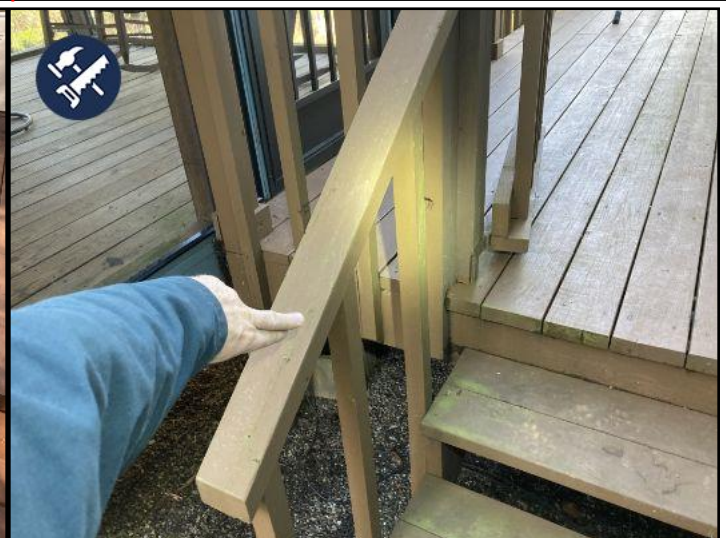
this handrail is loose at the rear deck.
Recommend repair by qualified contractor

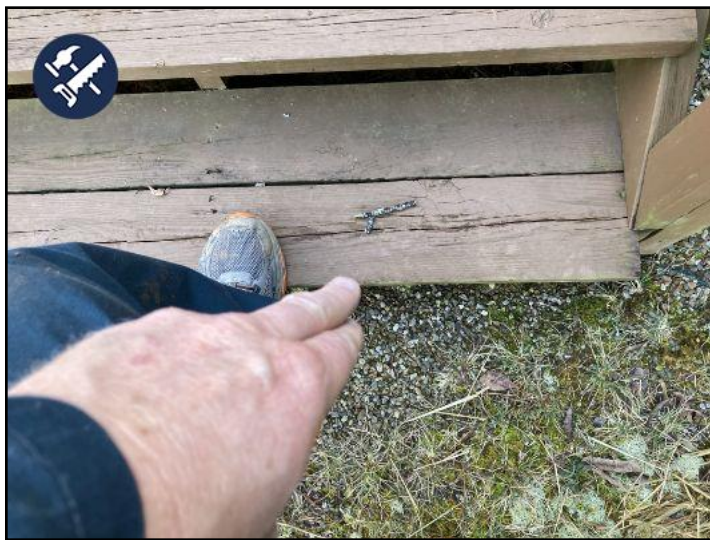
this bottom step off the rear deck...out to the back yard...is cracked and beginning to fail. Recommend replacement.

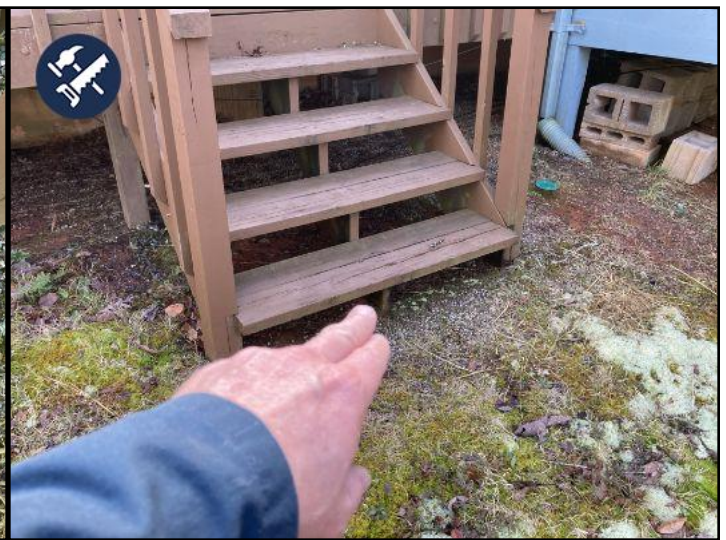
location of deteriorated step.
