PROPERTY INSPECTION REPORT

**Matthew Batson License #
True Value Home Inspections LLC**

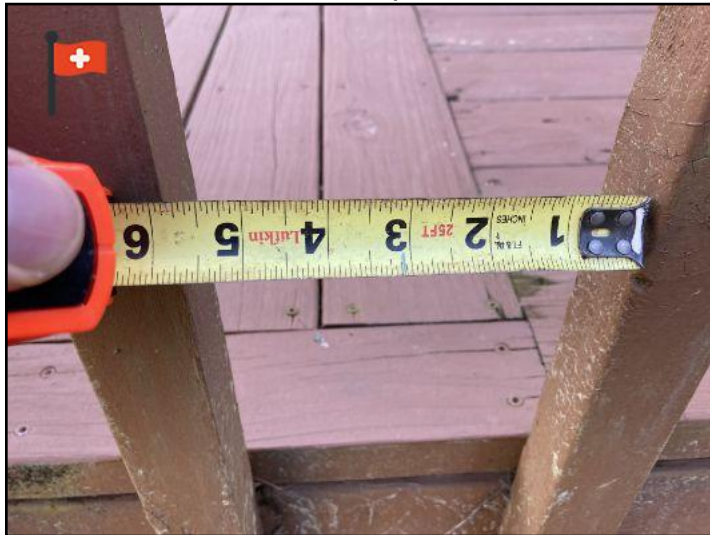
the balusters on the deck should not be more than 4 inches apart as to prevent a child from getting their head caught between them. While we are not code inspectors, we will still give the information and then let the parties involved decide on any action.

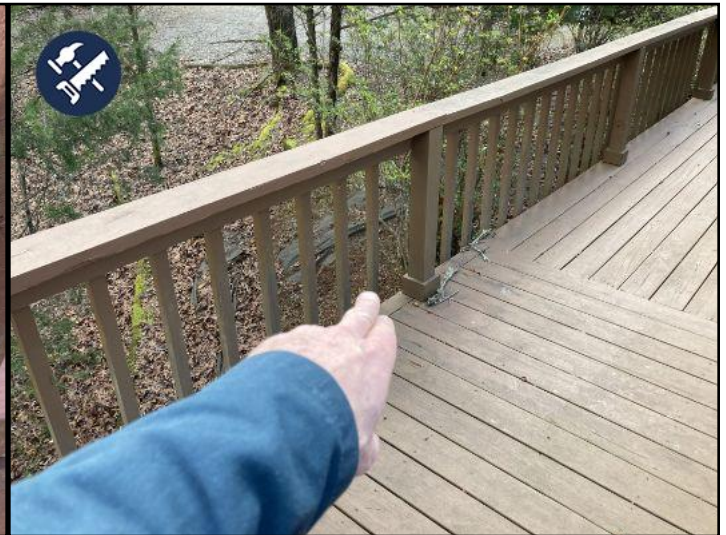
the hand rail on the deck...facing the front...south of the house...is loose and in need of reinforcement.

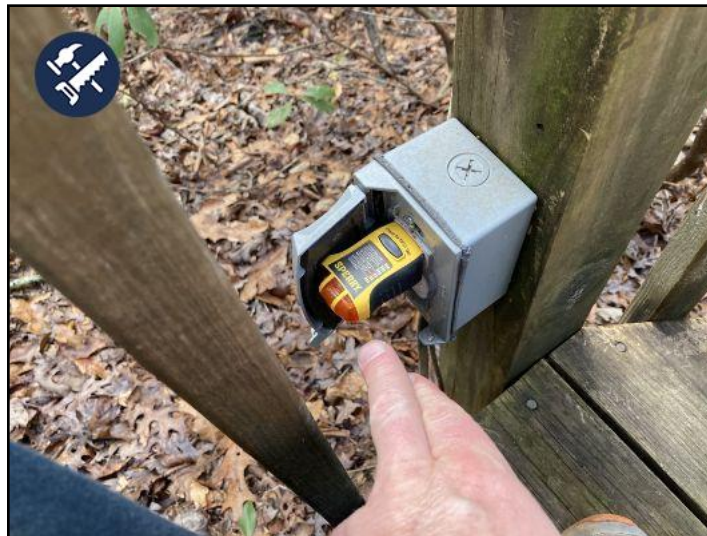
there is no power to the outlets that are on the long deck path down to the creek.

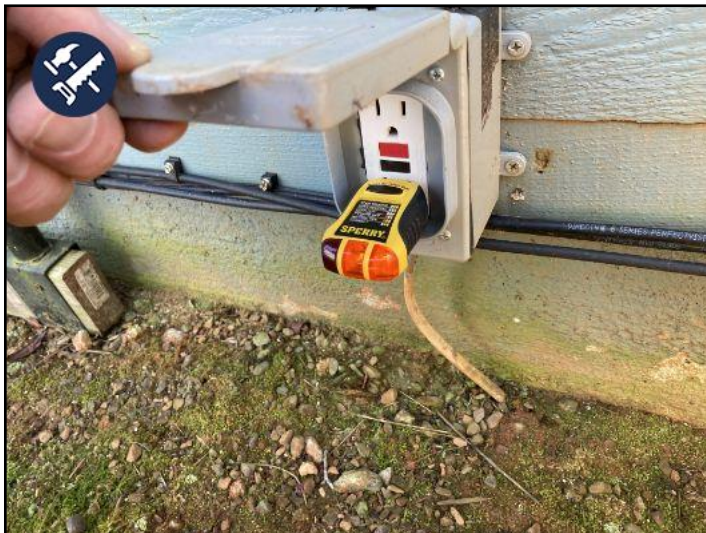
this GFCI did not trip to my tester. These wear over time and stop working. Recommend replacment by electrical contractor

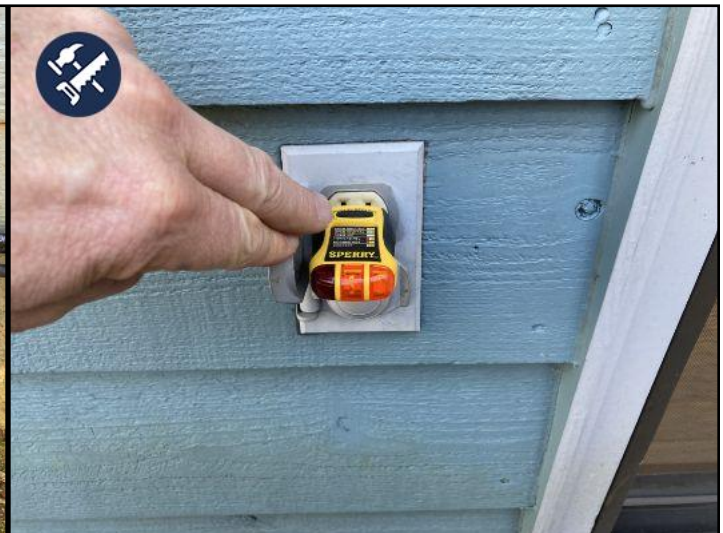
While we are not code inspectors, we will still supply information about certain codes....such as GFCI outlets required on the exterior of the home and the garage. Most of the outlets are not GFCI protected.

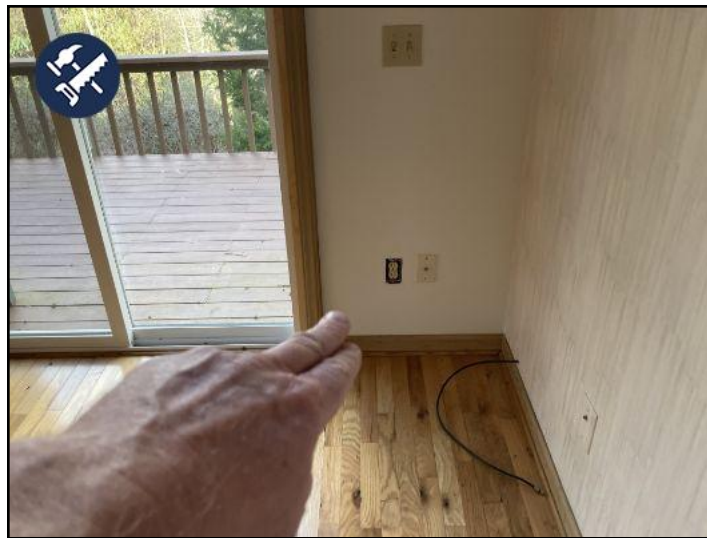
living room outlet needs a cover

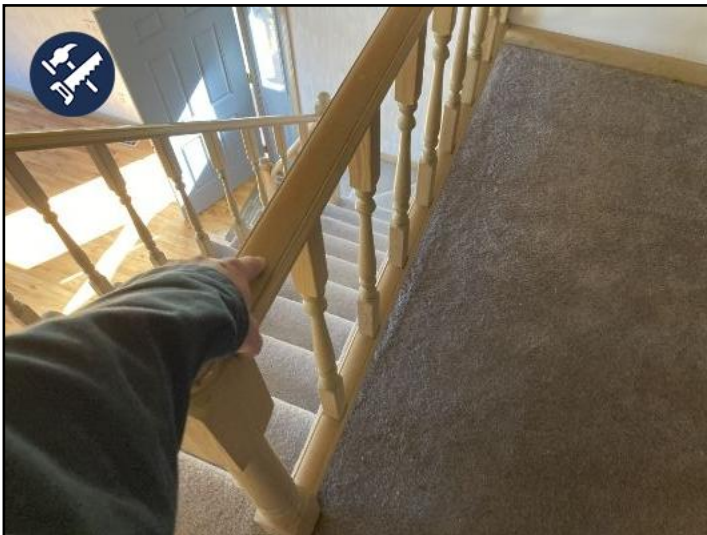
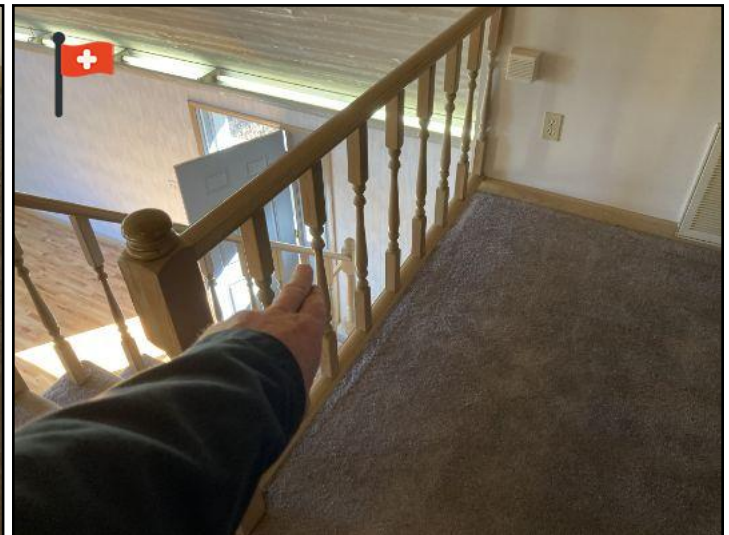
the handrail at the second floor loft is a bit loose. Recommend this be shored up/reinforced in case someone were to accidentally fall against it.

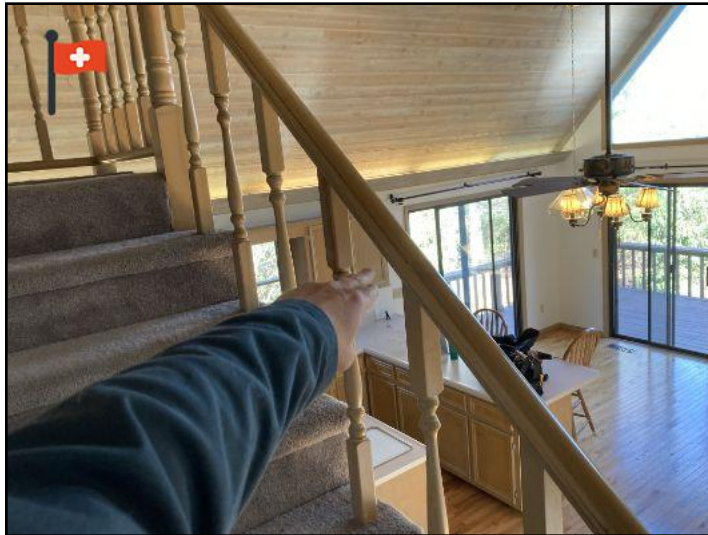
the handrail for the steps up to the upstairs loft are a bit loose. They feel as if they could be reinforced a bit to ensure safety if an accidental fall.

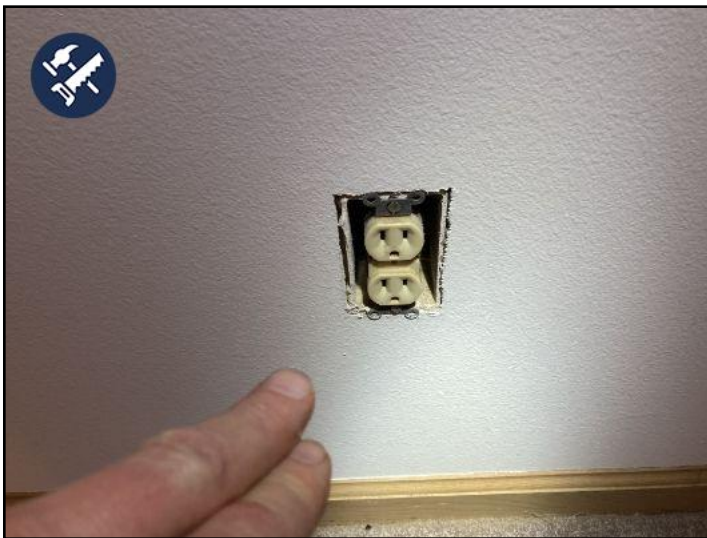
outlet needs a cover.

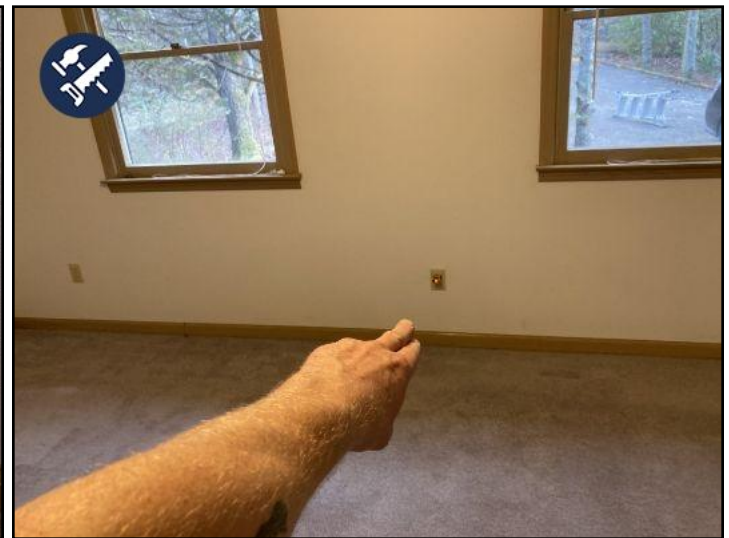
this outlet in the first floor bedroom is not grounded. This is the only one in the house...indicating to me that the receptacle itself was miswired or is defective. Recommend replacement

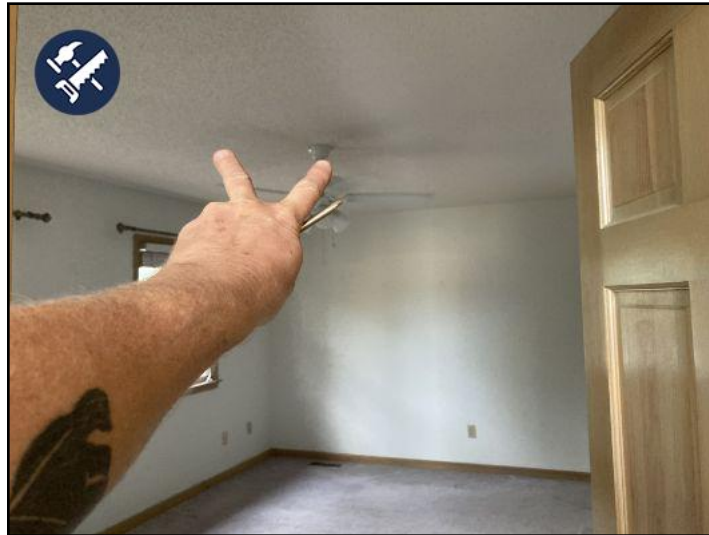
no smoke detectors in the bedroom downstairs. Recommend combination carbon monoxide/smoke detectors due to the wood burning fireplace in the home

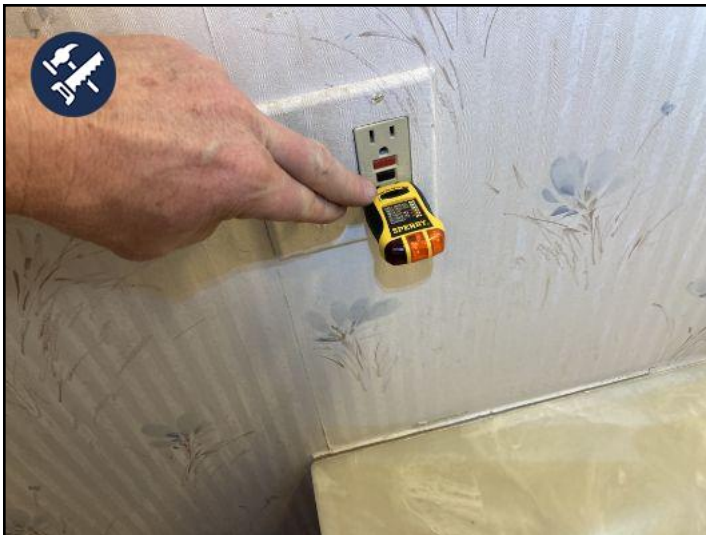
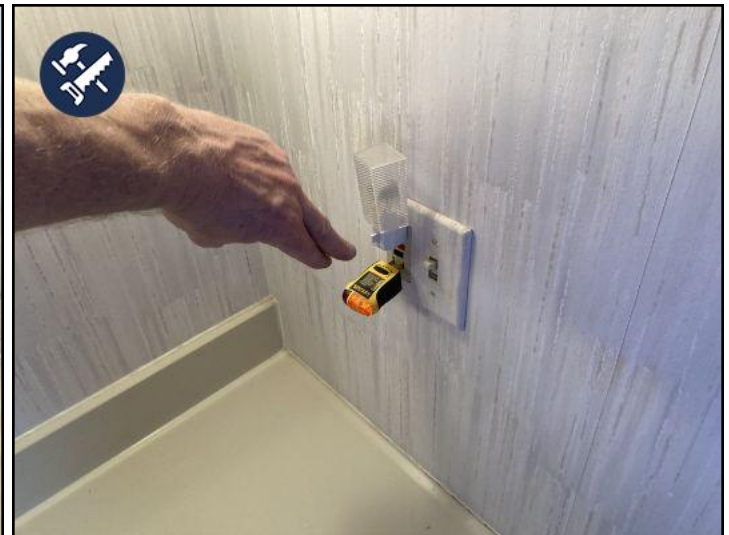
neither bathroom GFCI tripped on my tester. These wear out over the years. Recommend replacement.

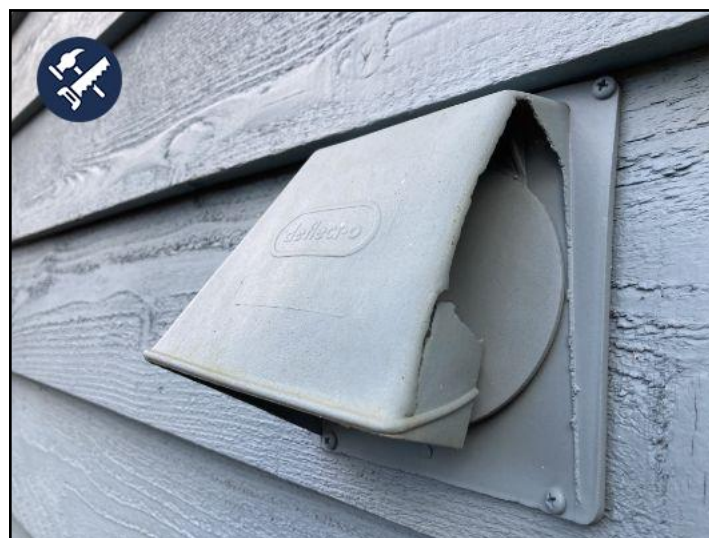
the upstairs bathroom vent is damaged. Recommend replacement.

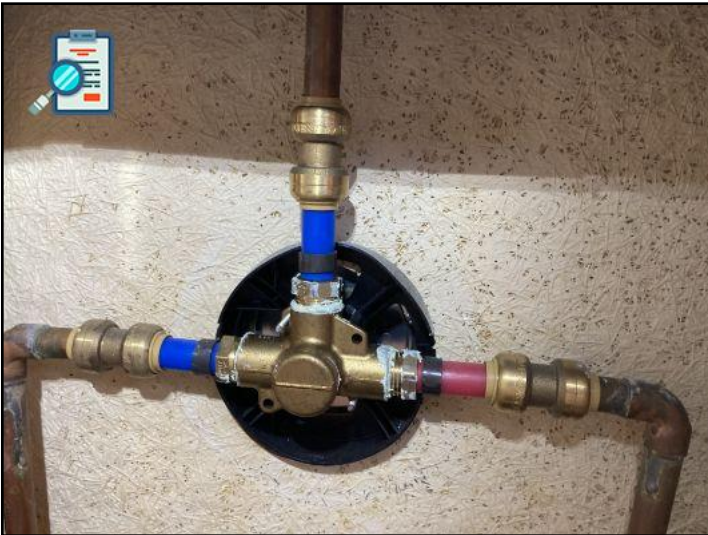
while the visible copper plumbing was in good shape...it will eventually fail. Unknown how long that could be....could be another 30 years.

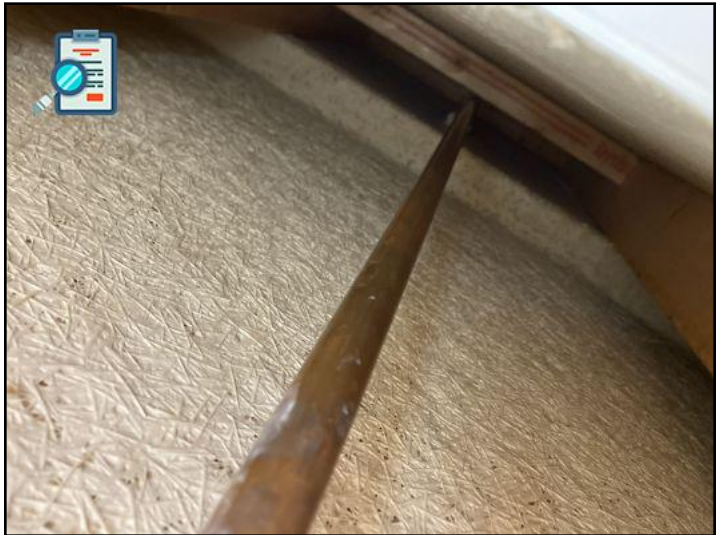
copper plumbing throughout the home. Copper has a life span and will eventually wear out/corrode and leak. Recommend budgeting for complete removal of all copper and replacement with pex.

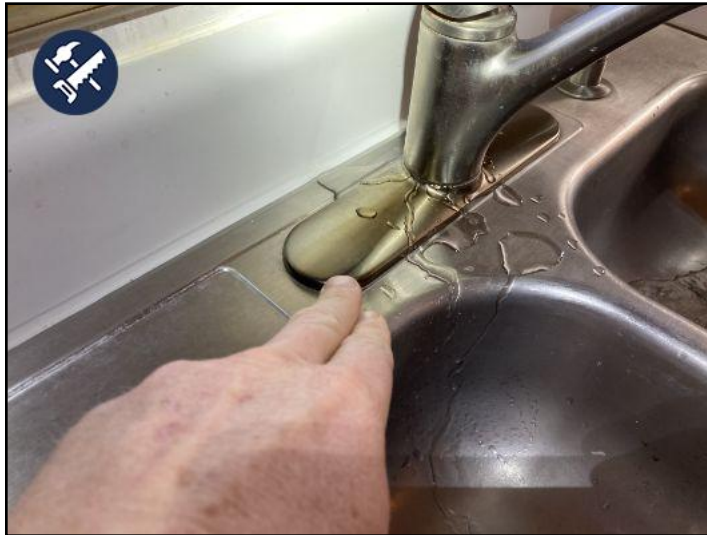
kitchen sink faucet leaks. Recommend replacment by plumbing contractor

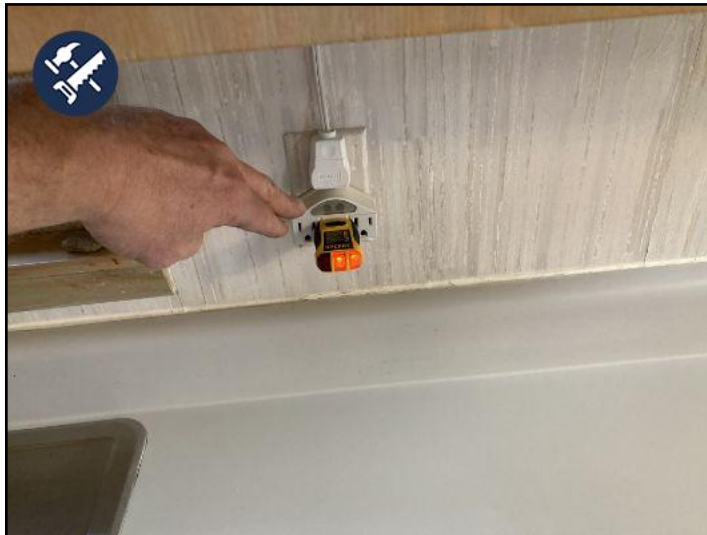
outlet next to kitchen sink is not a GFCI. This can be a shock hazard. Recommend replacement by electrical contractor

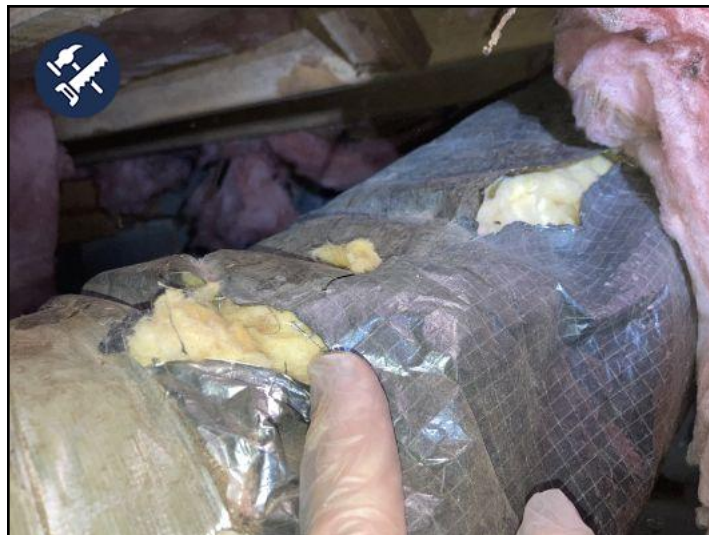
Observations:
• **several places of damage/tears to the HVAC supply duct in the crawlspace.**

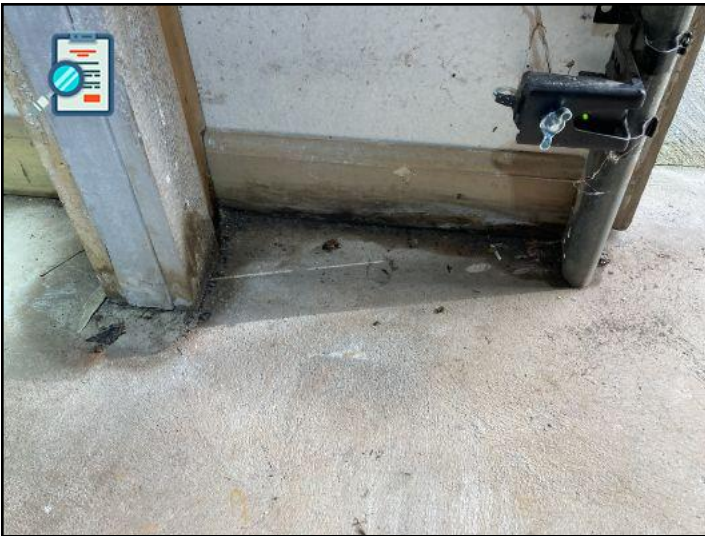
some water staining next to garage door...is not wet currently and wood is still structurally fine...monitor for possible water issues

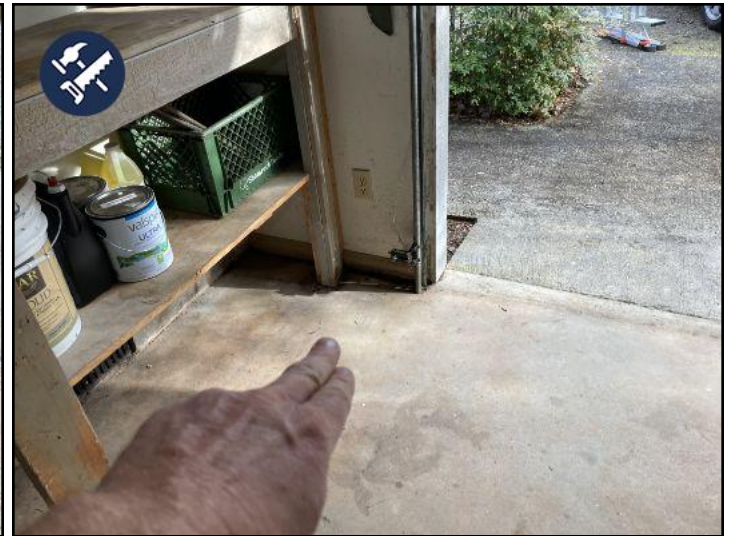
possible old water stains.

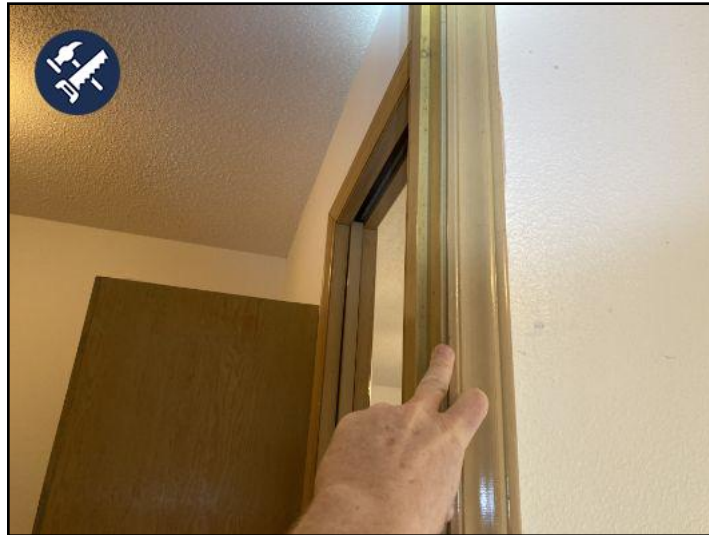
the door to the house from the garage has no weatherstip. This is important due to fumes in the garage that could possibly penetrate to the home interior. Recommend installation of weatherstrip here.

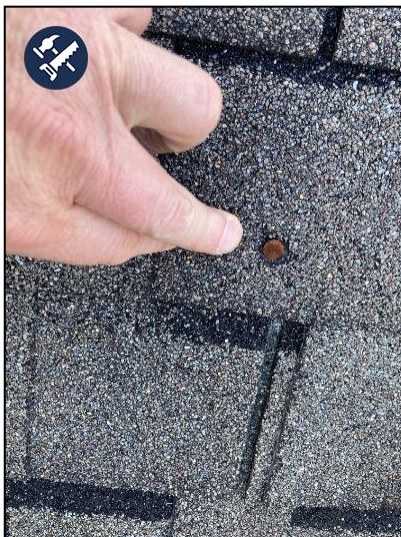
a nail in the exposure part of the shingle is not proper building practice. Recommend a dab of roofing cement over this nail head.

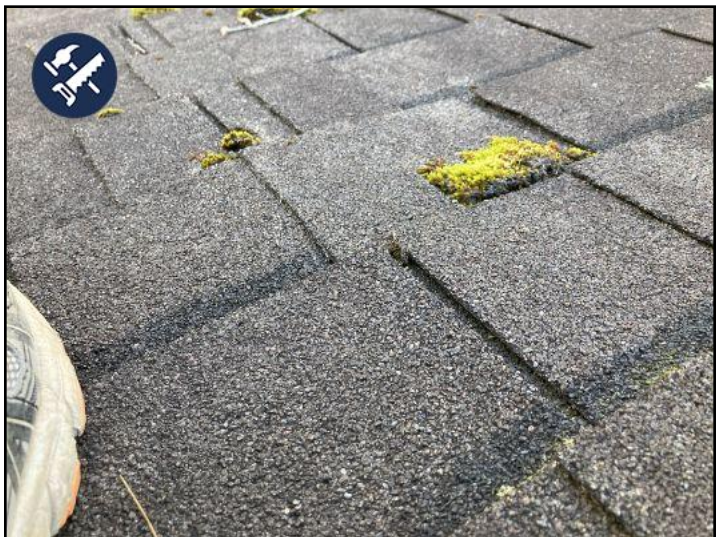
moss on the roof will shorten an asphalt shingles lifespan. Recommend spraying a fungicide on the affected areas every couple of years.

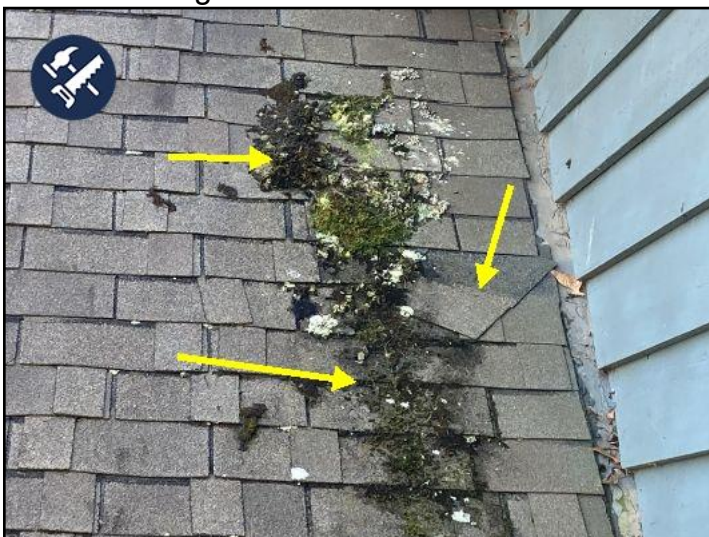
a shingle tab has slid down out of place. It does not appear to be leaking at this time...however it should be repaired by a roofing contractor. Also the moss growing here needs to be sprayed with fungicide.

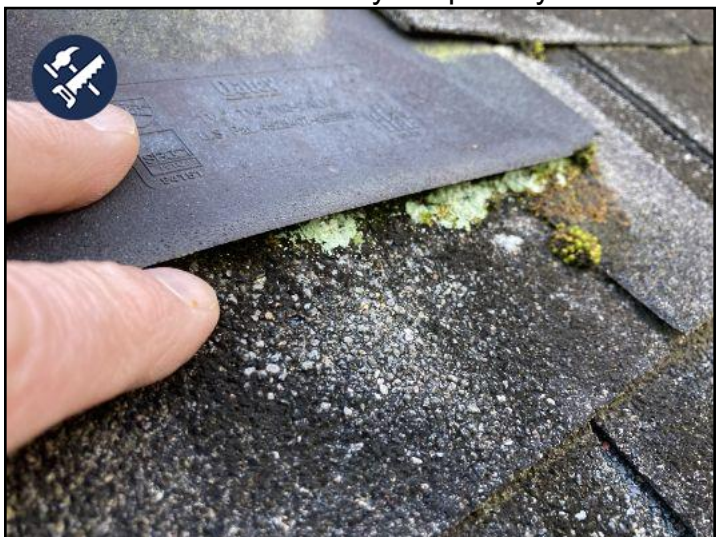
most of the mold is on the north facing parts of the roof

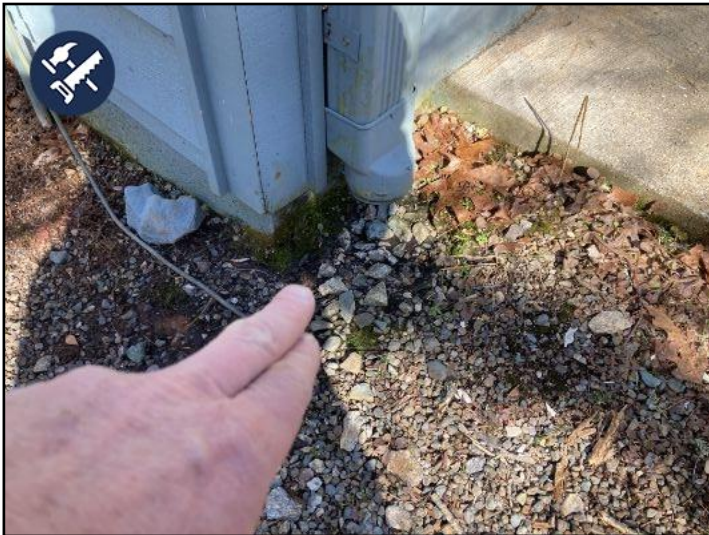
gutter downspout needs an extension to ensure water is discharged further away from the foundation. This will cause issues with the foundation over time...washing soil away and introducing excessive moisture next to the home.

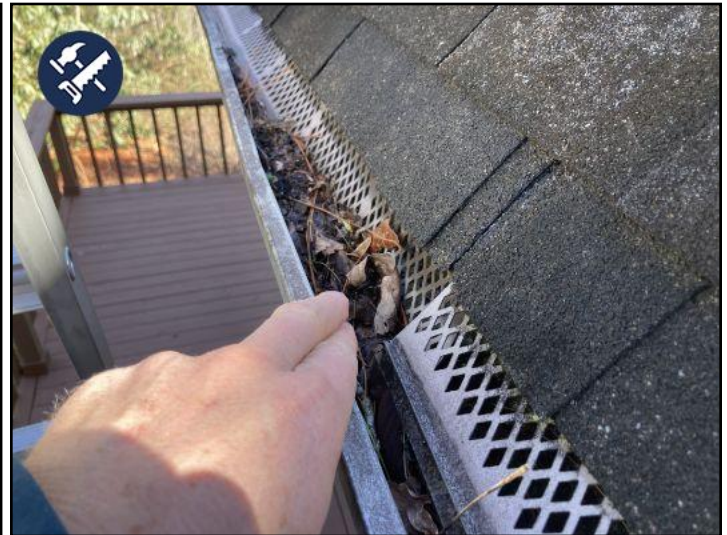
a couple spots of the gutter guard are in disrepair and leaves are accumulating. Recommend cleaning gutters and popping this back into place in the gutter.

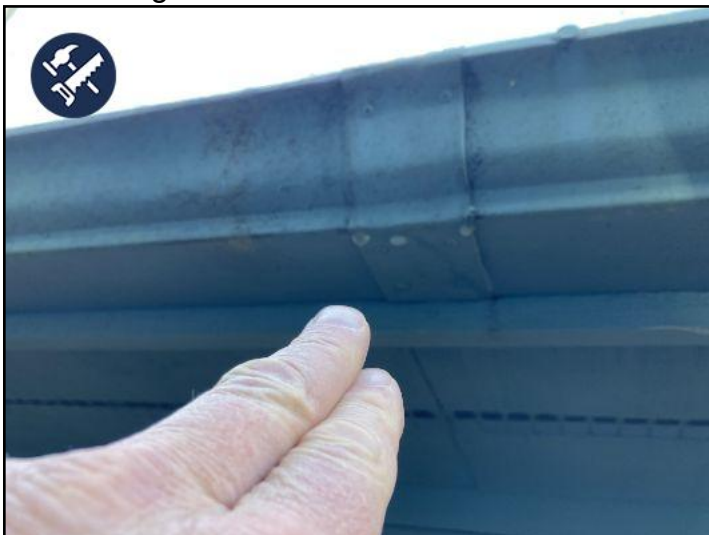
leaking gutter at the detached covered porch in the back. This is introducing moisture next to the deck. Recommend sealing with some gutter glue.

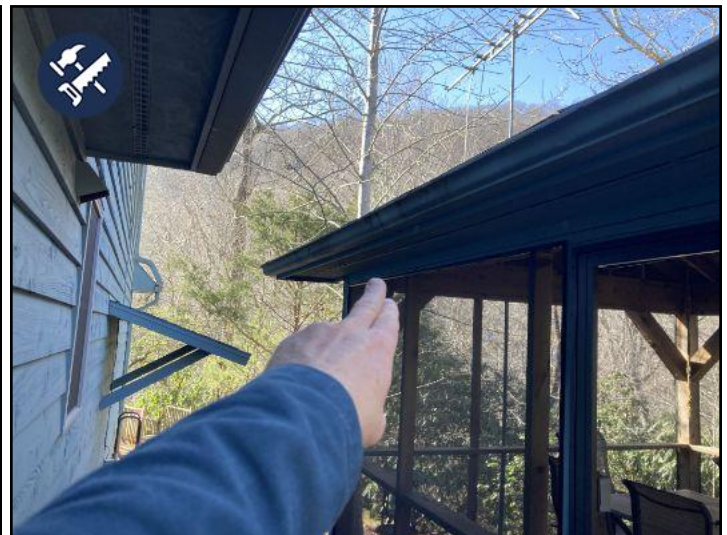
location of leaking gutter.

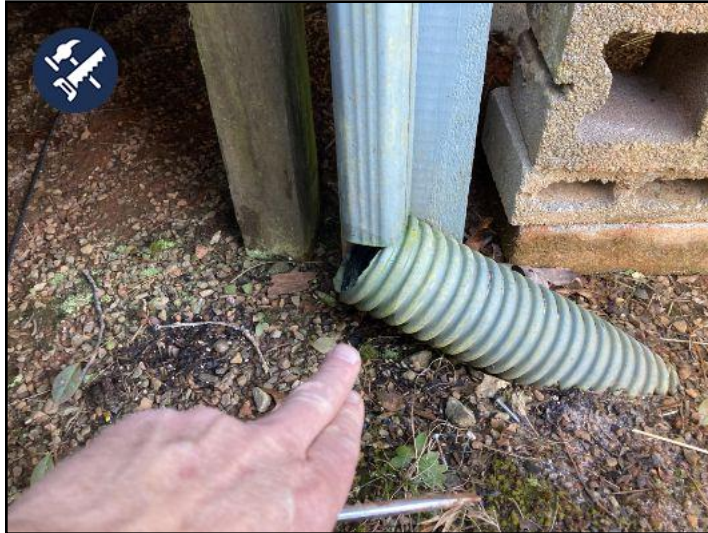
downspout is not connected to the drain pipe. Recommend correction to ensure water is discharged away from the home.

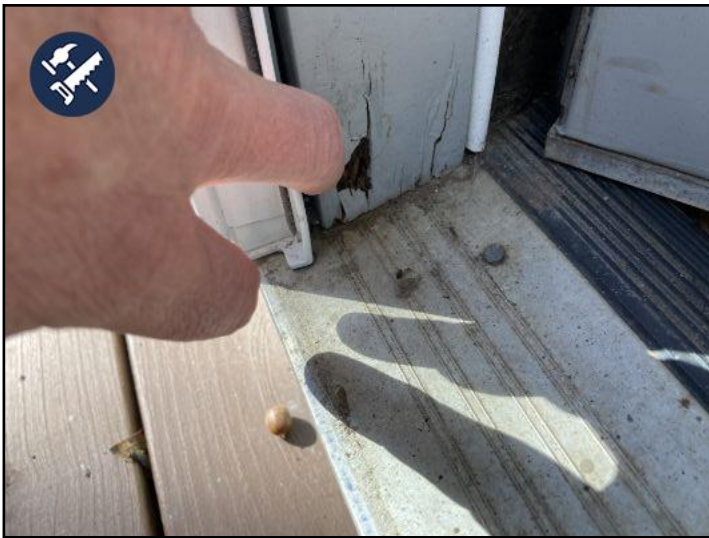
front entry door has some rotting wood on its frame. Recommend repair by qualified contractor

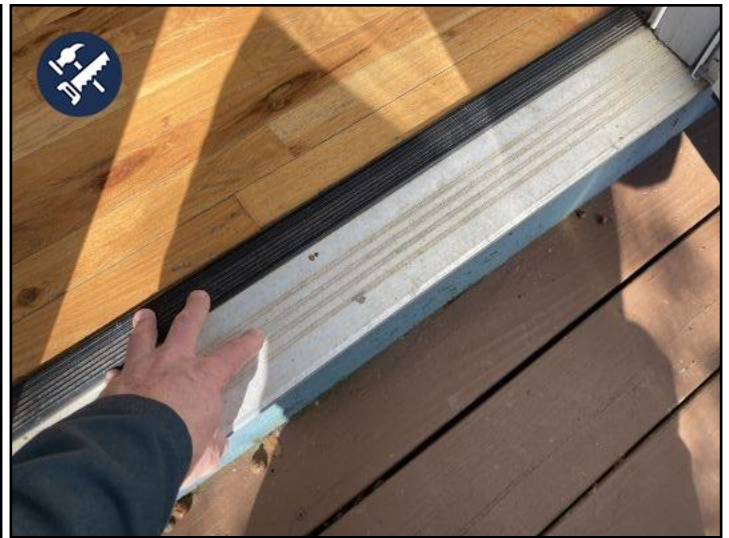
front door threshold is loose and in disrepair. Recommend repair or replacement by qualified contractor

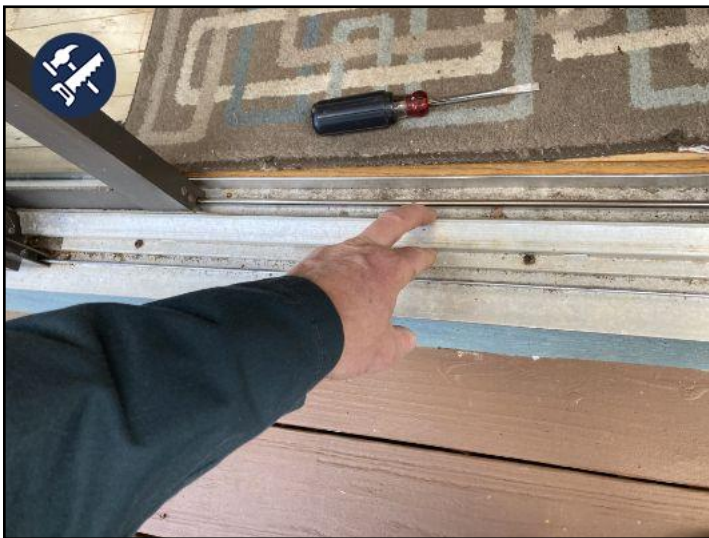
sliding glass door facing the back has a loose track/guide. The screws securing this are loose. Recommend repair.

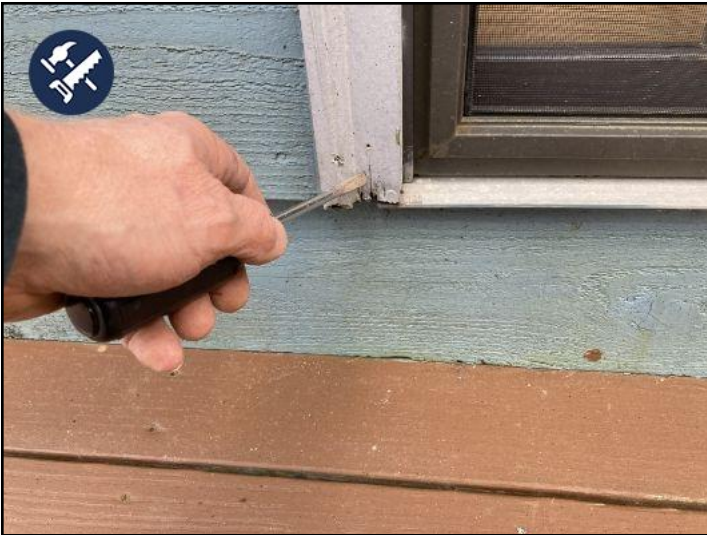
This trim at sliding glass door is beginning to rot. Door facing back yard. Recommend repair by qualified contractor

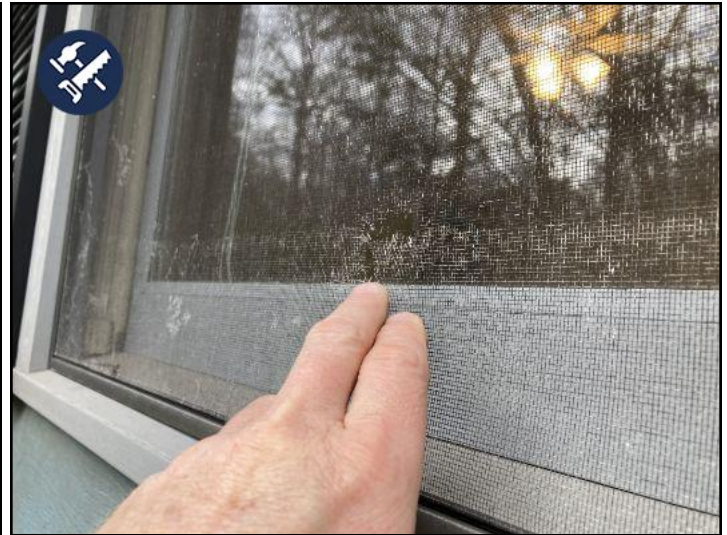
the two front bedroom windows have screens that are damaged. Recommend replacement.

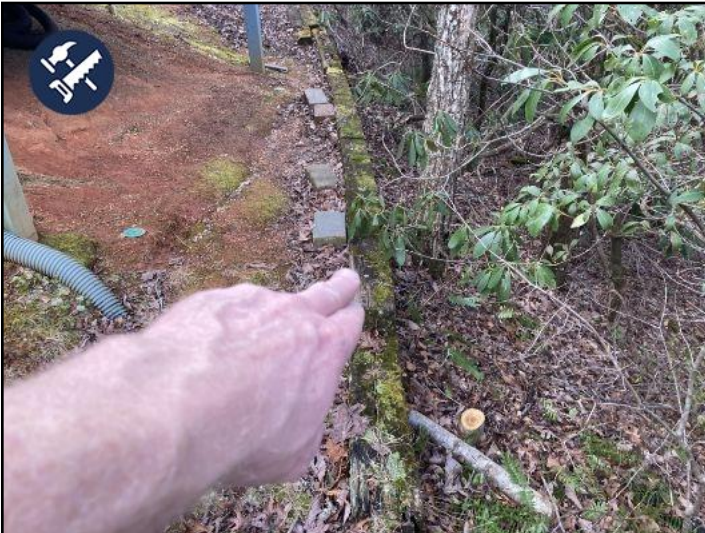
the retaining wall at the back of the home is in disrepair. The railroad timber used is rotted and failing. This wall will need to be replaced in the near future.

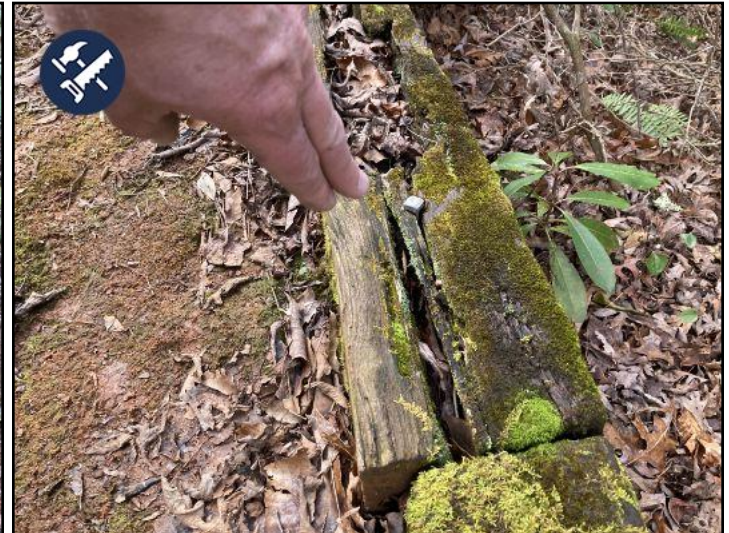
retaining wall is rotting.

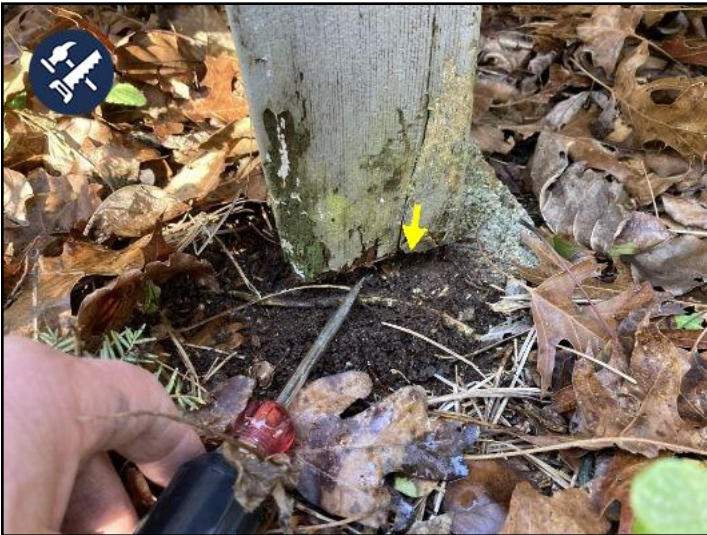
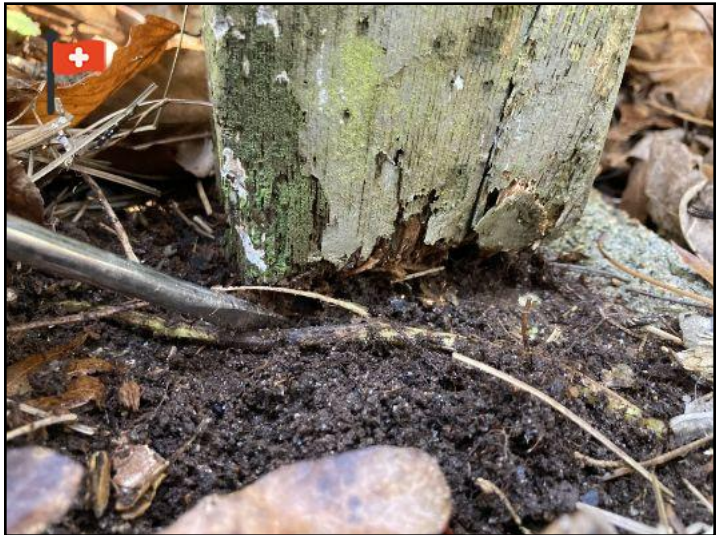
several fo the 4x4 support posts on the deck (at the front , sides and back) are rotting at the point where they meet their concrete footers. Recommend replacment, and considering using 6x6 posts with metal brackets to separate the bottom of the wood post from the concrete.

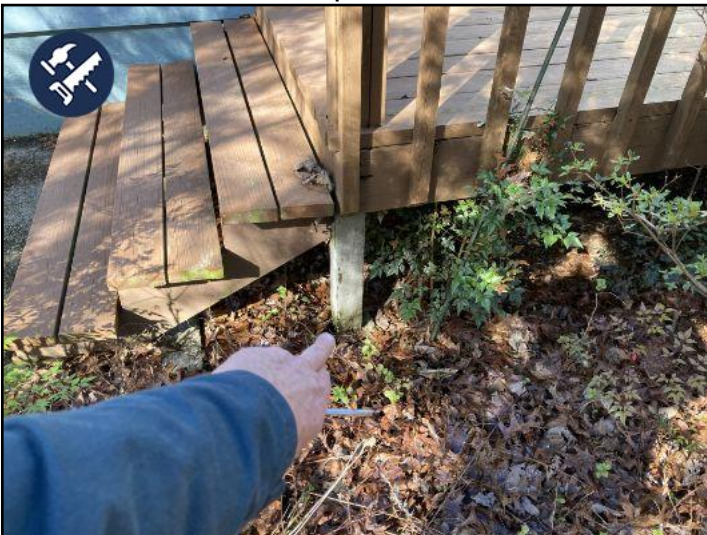
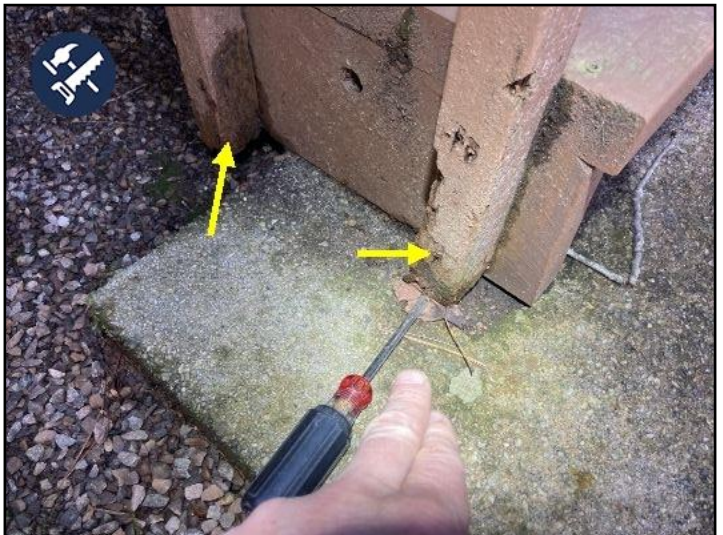
at the steps to the rear deck nearby the a/c compressors....there is rotted wood at the balusters. This handrail is also loose and in need of reinforcement.

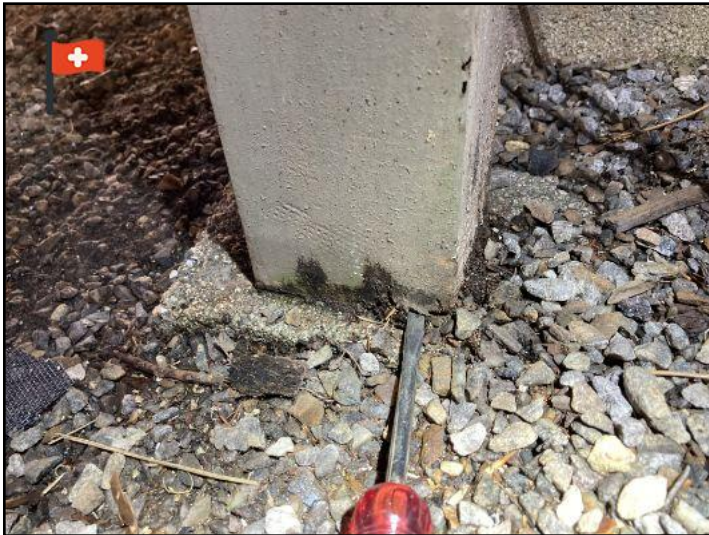
another 4x4 post that is beginning to rot from water exposure/contact with concrete footer.

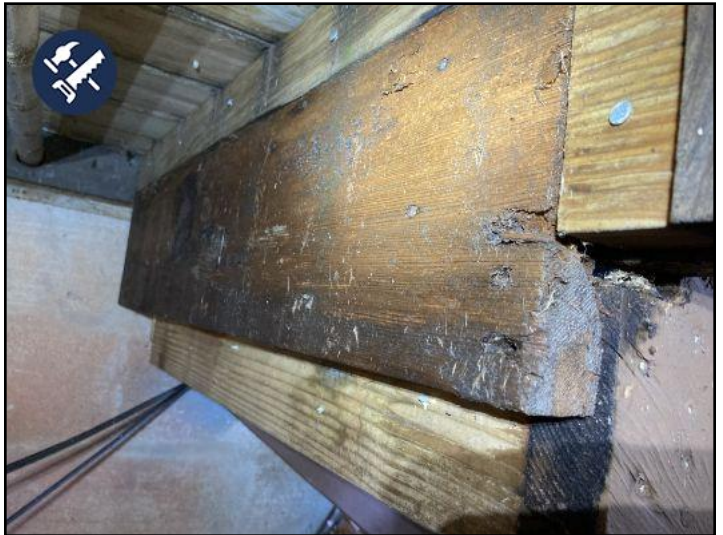
This ledger board for the rear deck steps (next to a/c compressors) is very wet and is rotting/soft. This needs to be replaced by a qualified contractor.

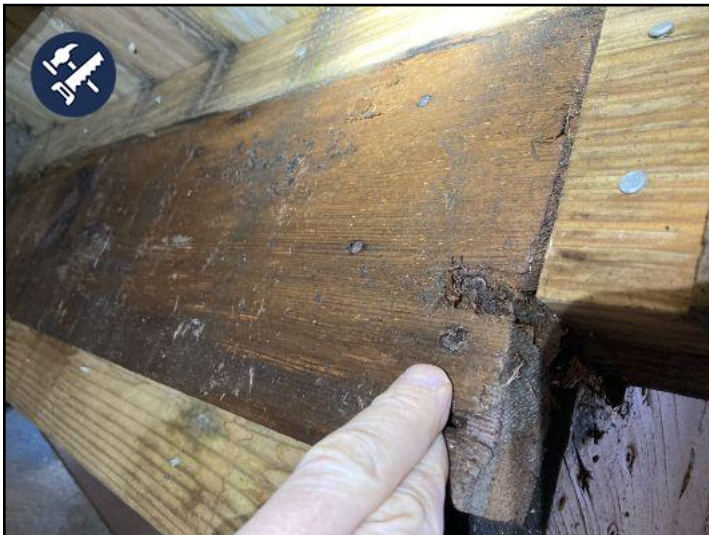
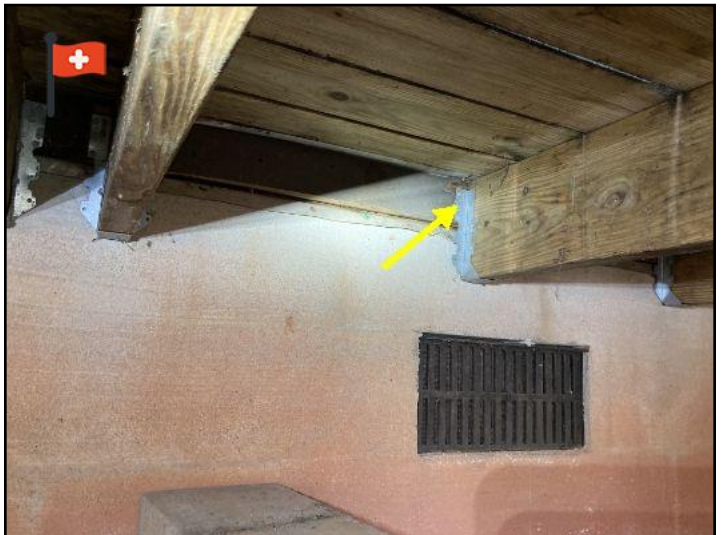
the deck is not properly attached to the home. Most deck failures occur at the attachment point at the house. The hangers for the joists are not fully bearing on the ledger. The ledger is not bolted or structurally screwed to the home. Recommend evaluation and repair by qualified contractor

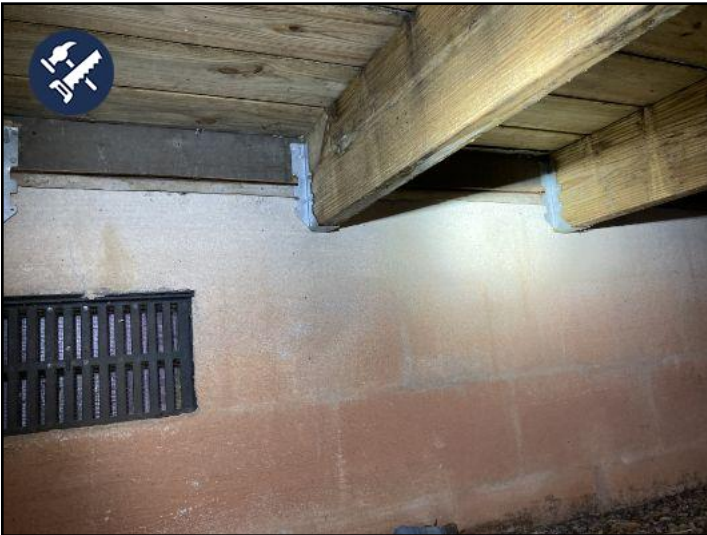
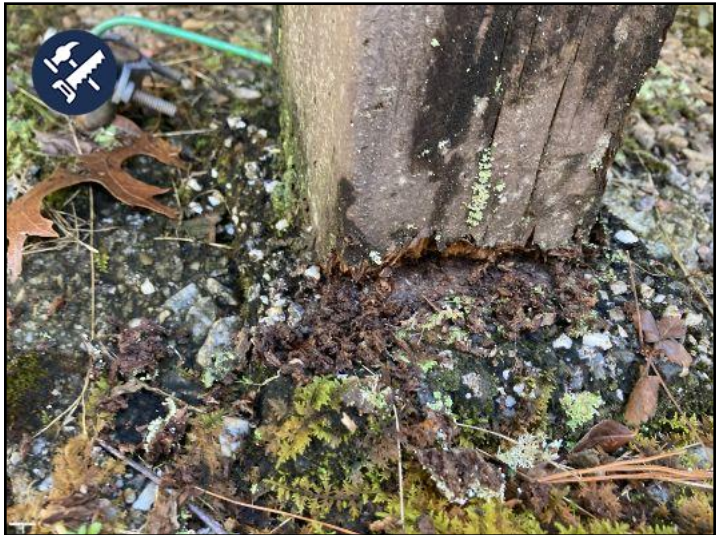
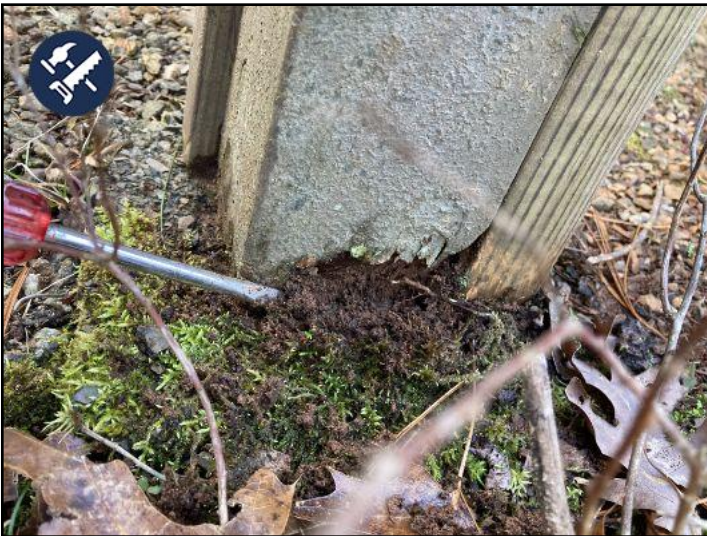
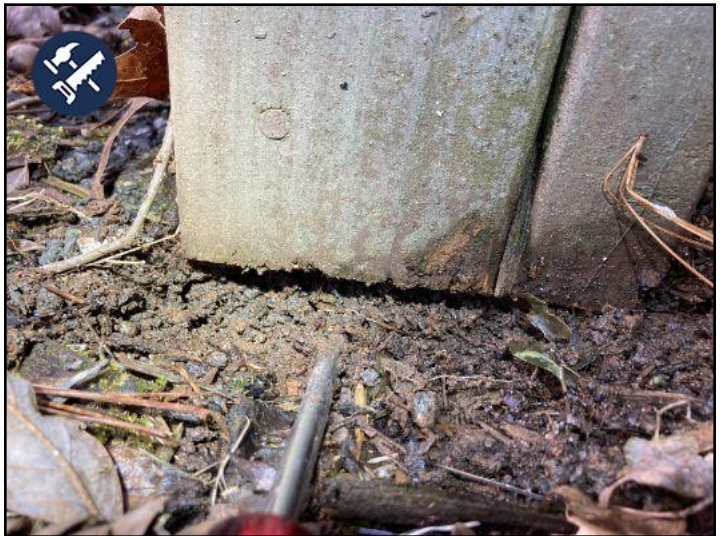
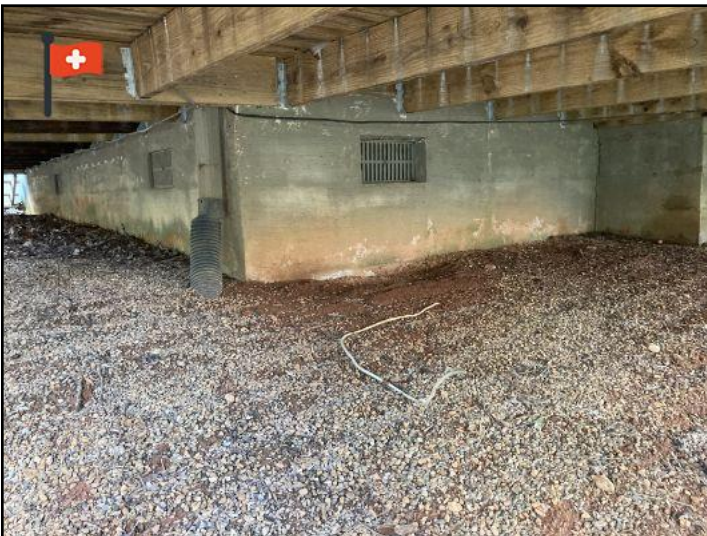
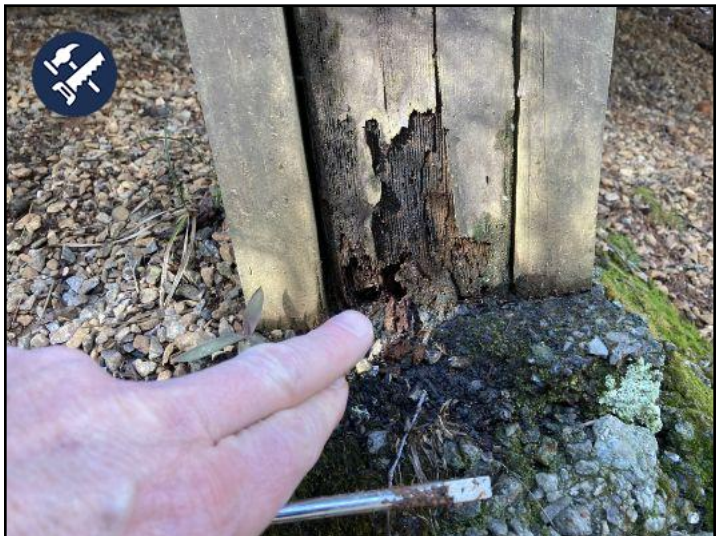
the deck at the house is a safety hazard. With enough people on it this deck could collapse with its improper attachment to the home. 85% of deck failures occur at the attachment to the home. This deck needs to be repaired immediately

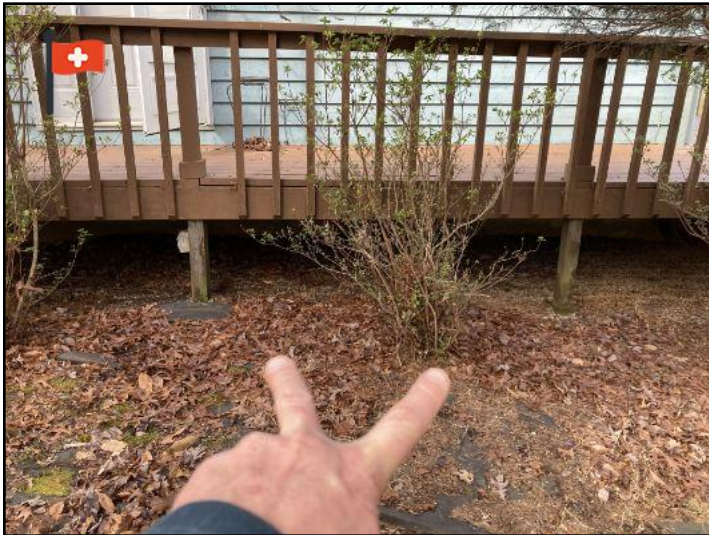
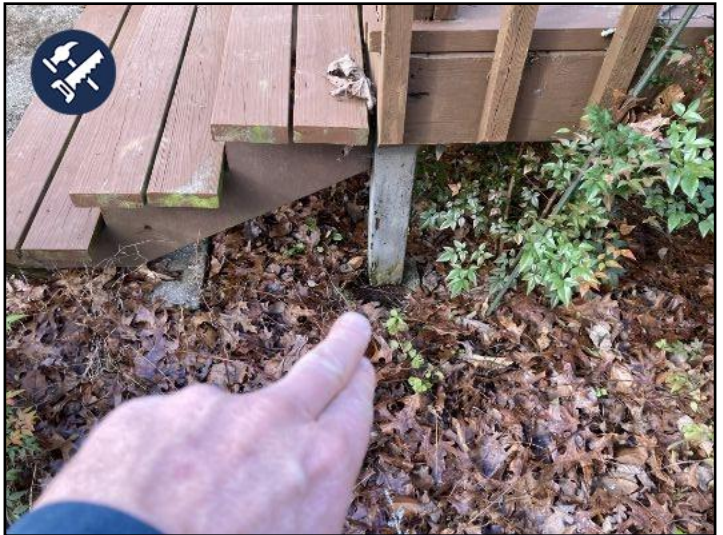
these two 4x4 posts are rotting...among others on the deck. This is a safety hazard as the deck is not properly supported and is not performing as designed.
