PROPERTY INSPECTION REPORT

**Matthew Batson License #
True Value Home Inspections LLC**

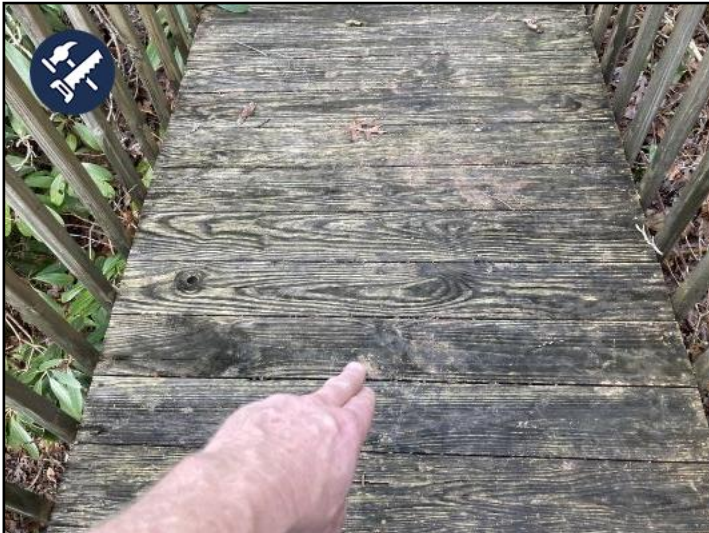
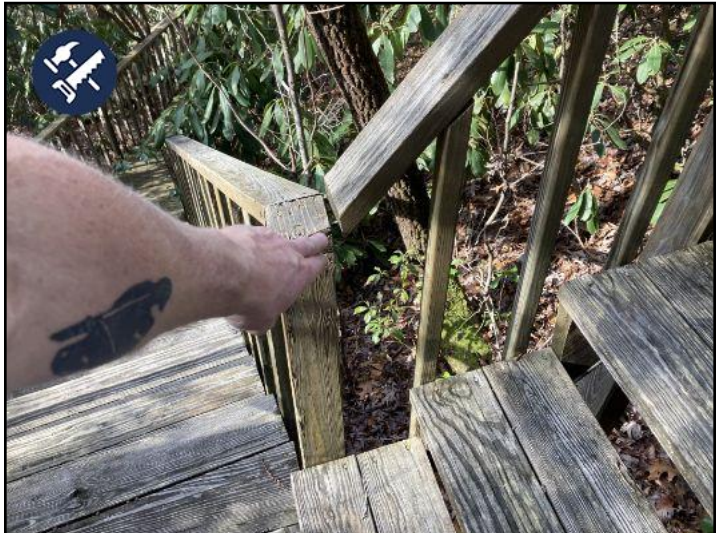
there are several areas of the deck down to the creek that are in need of treatment/washing and staining/paint. The wood decking is heavily weathered.

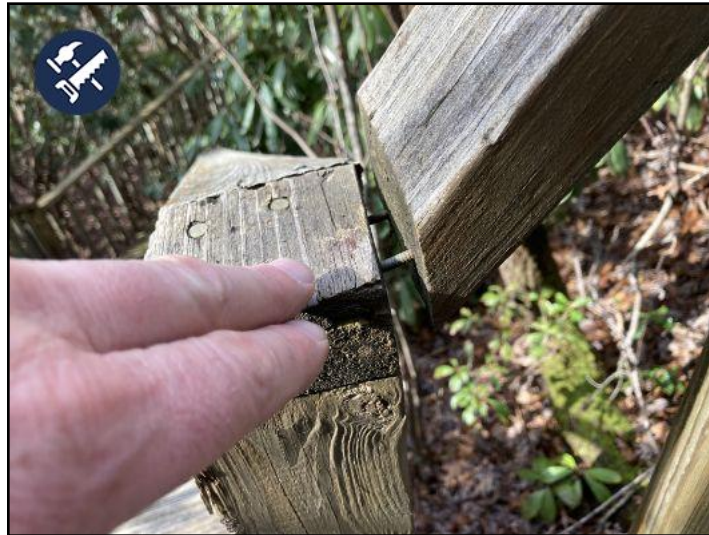
handrail is coming loose from its mount here...recommend repair

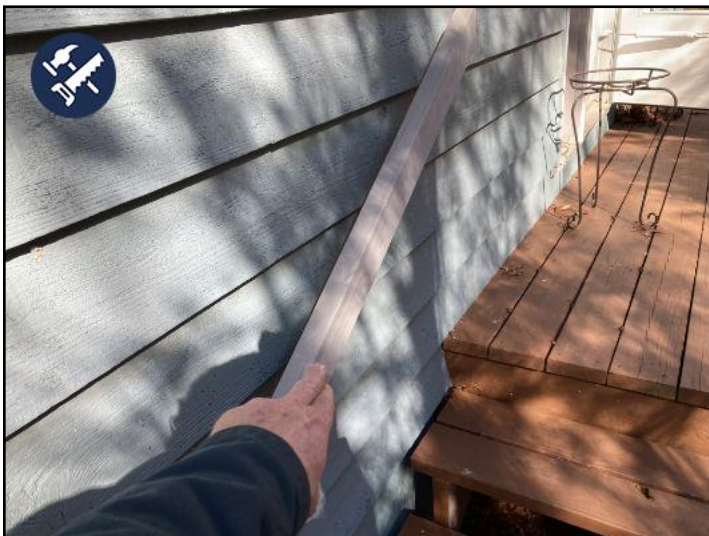
handrail at front entry steps is loose. Recommend repair.

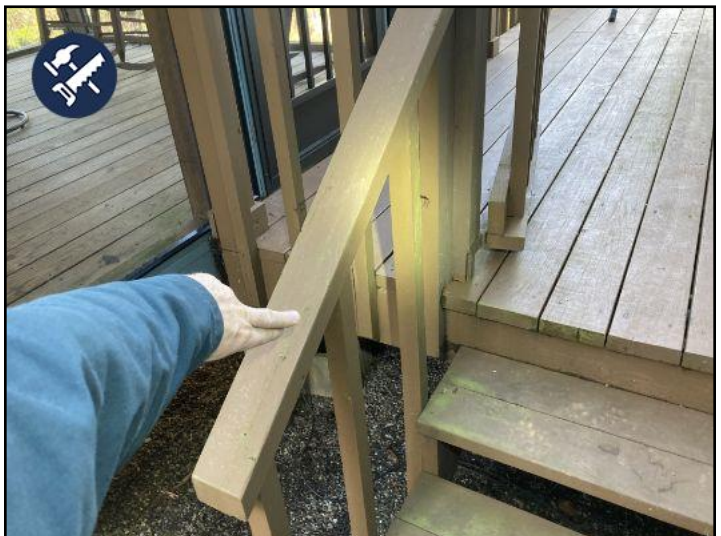
this handrail is loose at the rear deck. Recommend repair by qualified contractor

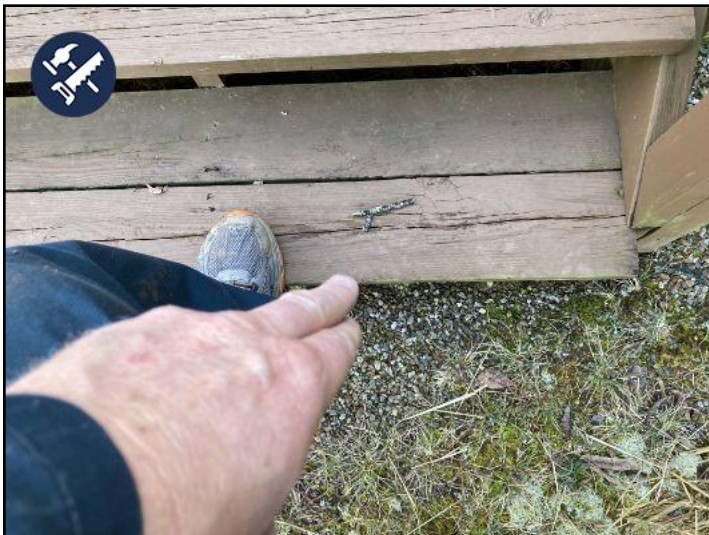
this bottom step off the rear deck...out to the back yard....is cracked and beginning to fail. Recommend replacement.

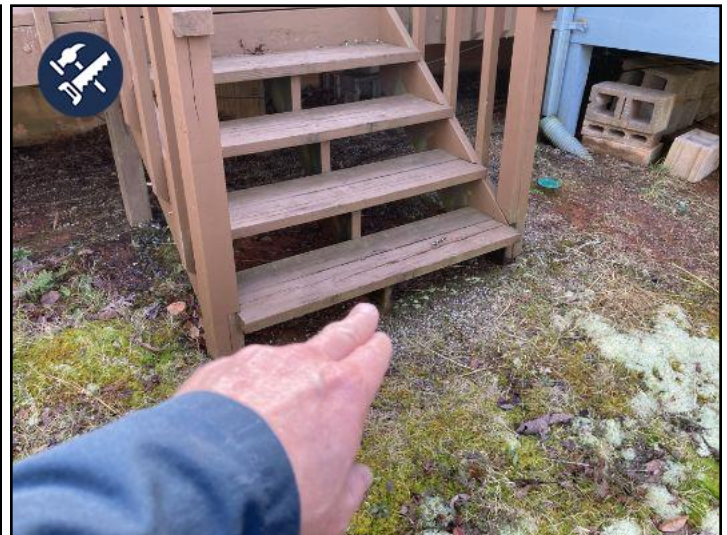
location of deteriorated step.

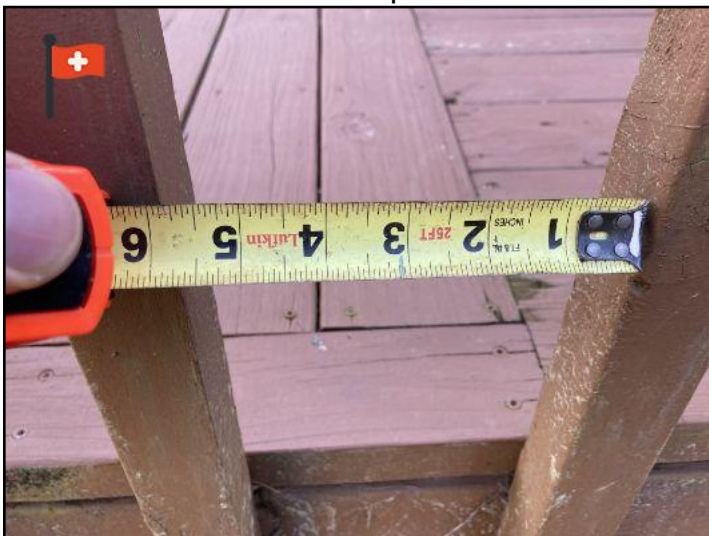
the balusters on the deck should not be more than 4 inches apart as to prevent a child from getting their head caught between them. While we are not code inspectors, we will still give the information and then let the parties involved decide on any action.

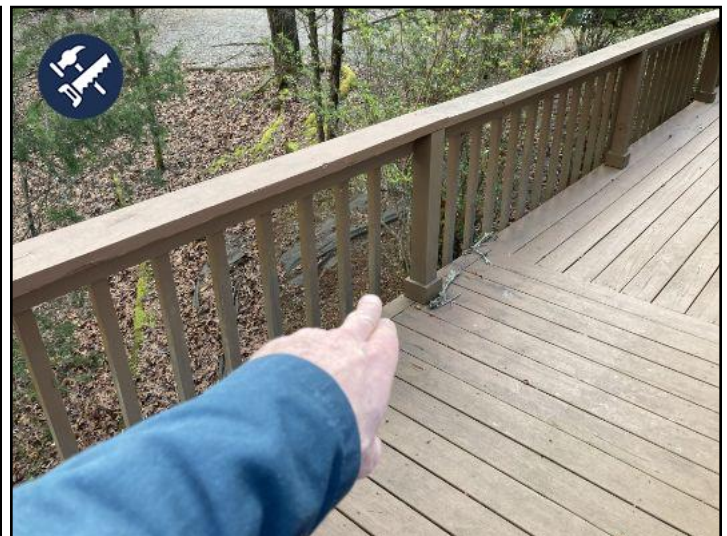
the hand rail on the deck...facing the front...south of the house...is loose and in need of reinforcement.

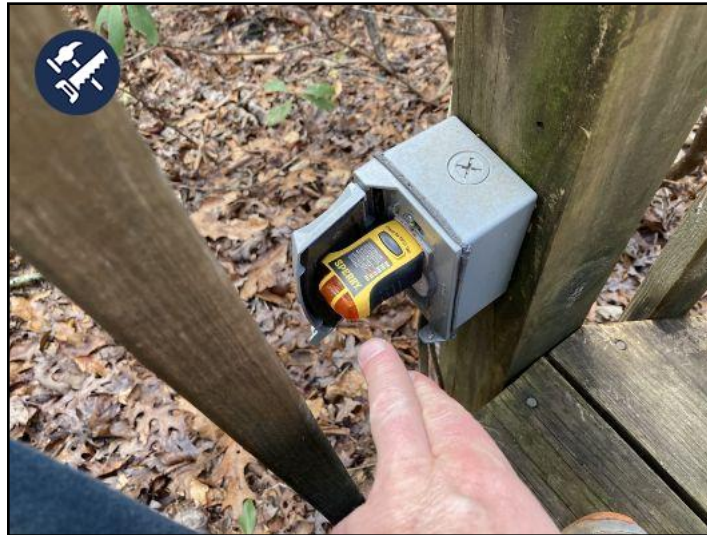
there is no power to the outlets that are on the long deck path down to the creek.

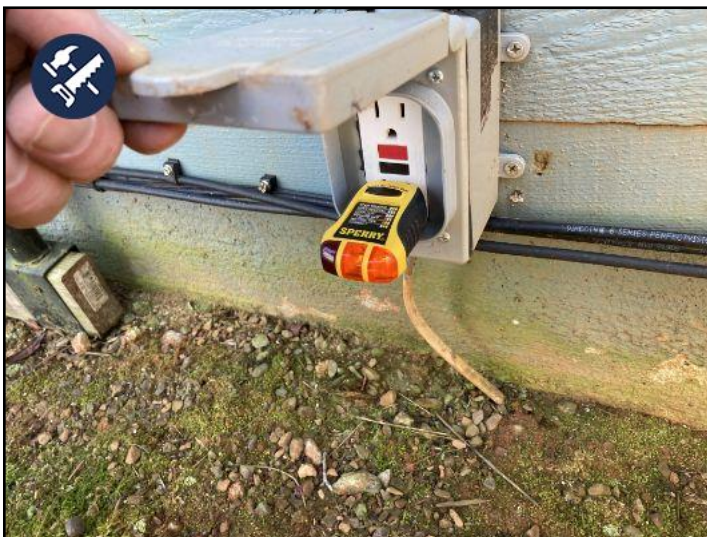
this GFCI did not trip to my tester. These wear over time and stop working. Recommend replacment by electrical contractor

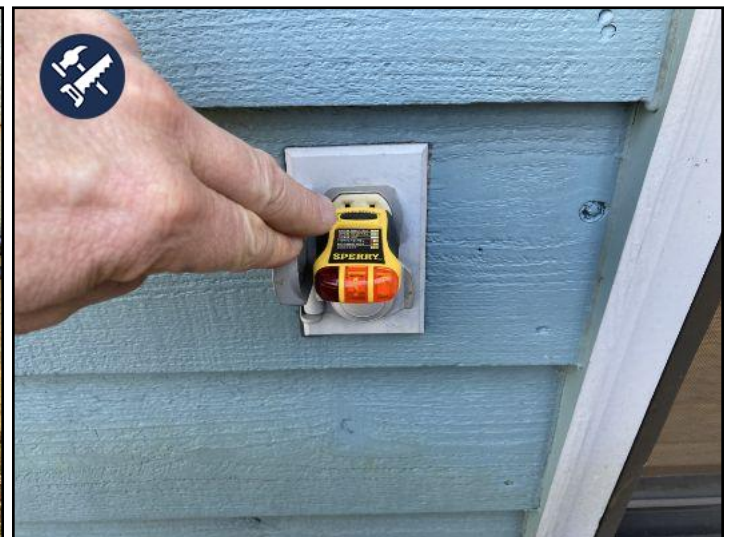
While we are not code inspectors, we will still supply information about certain codes....such as GFCI outlets required on the exterior of the home and the garage. Most of the outlets are not GFCI protected.
